Before and After

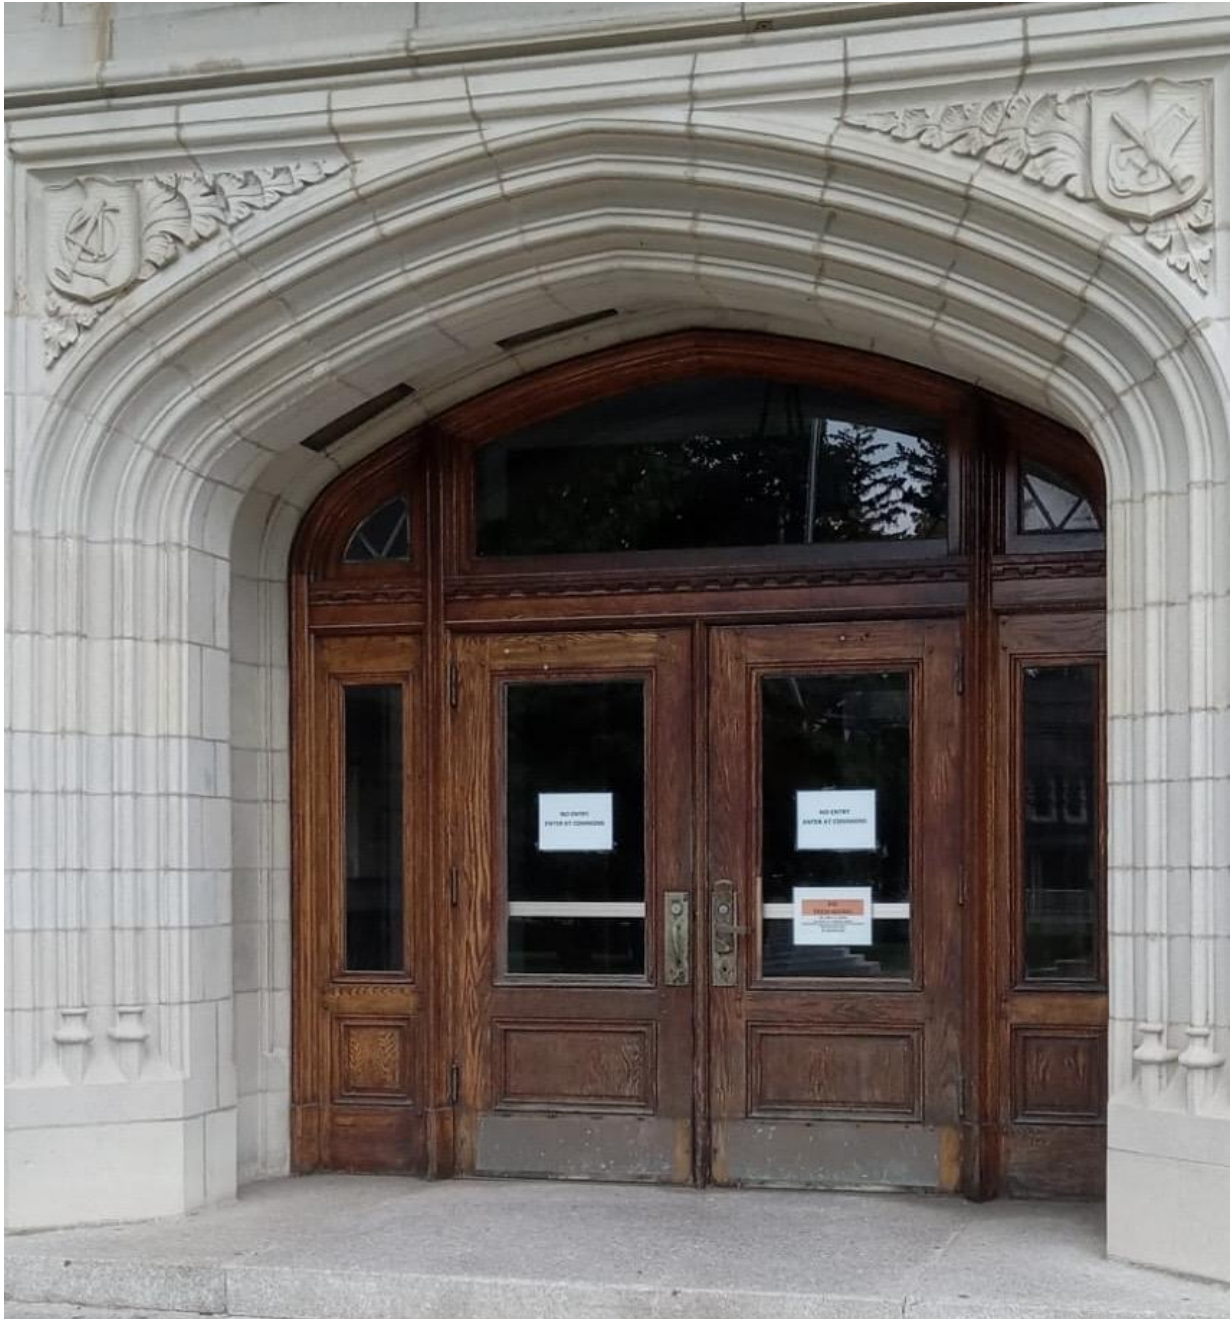
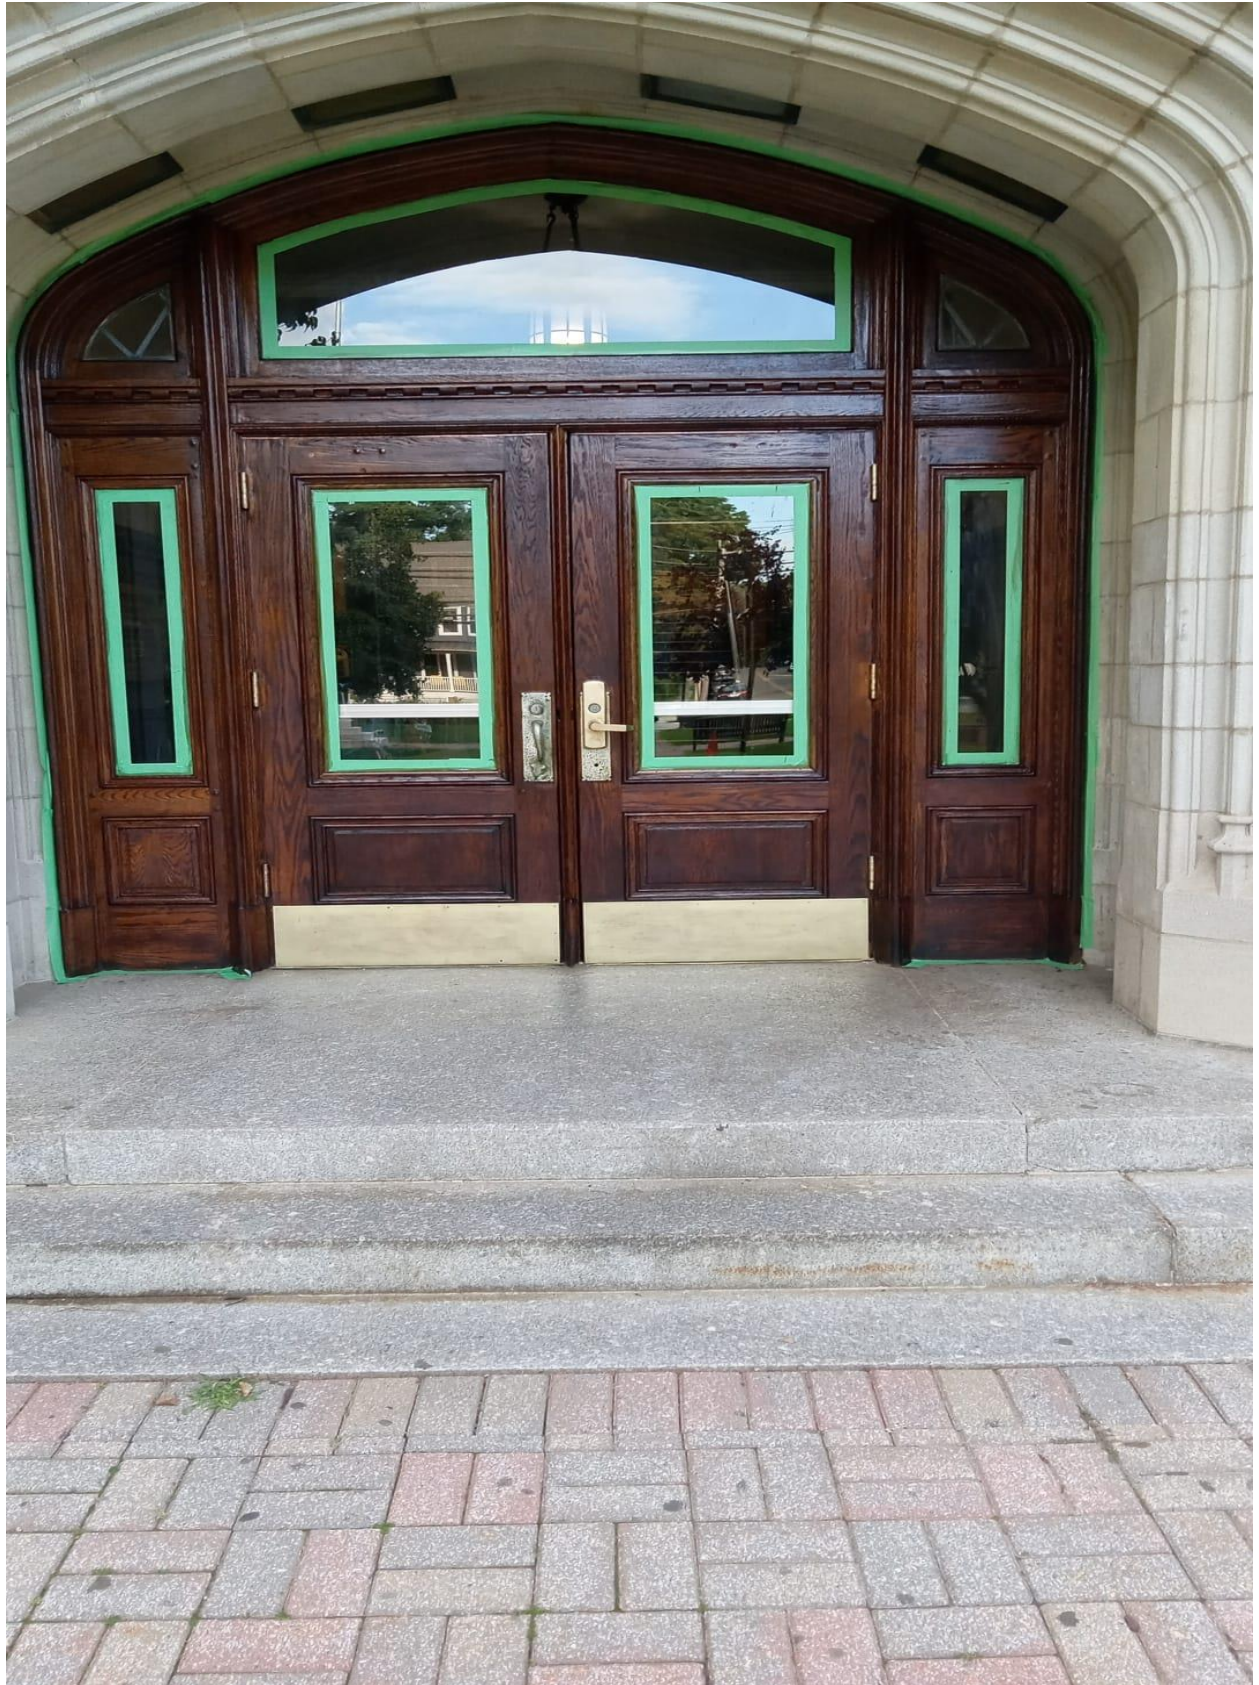
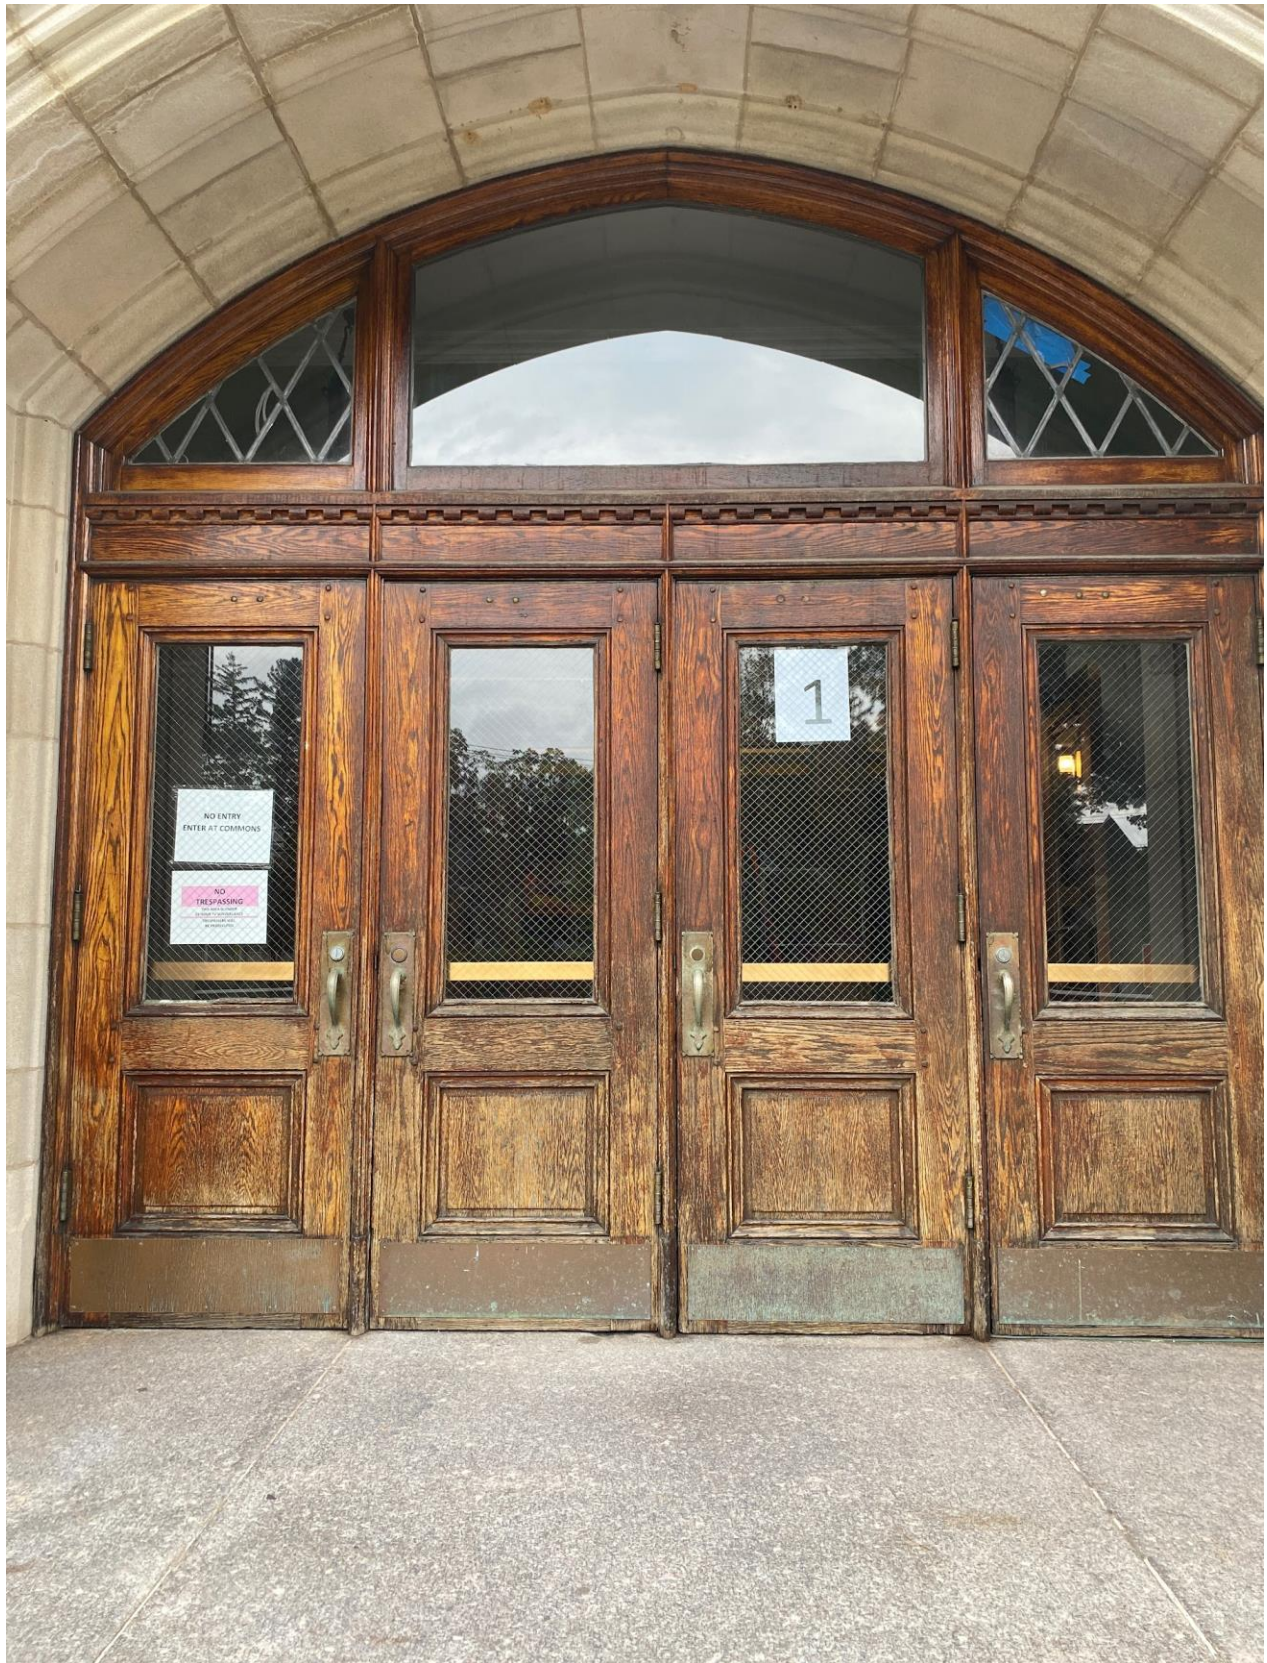
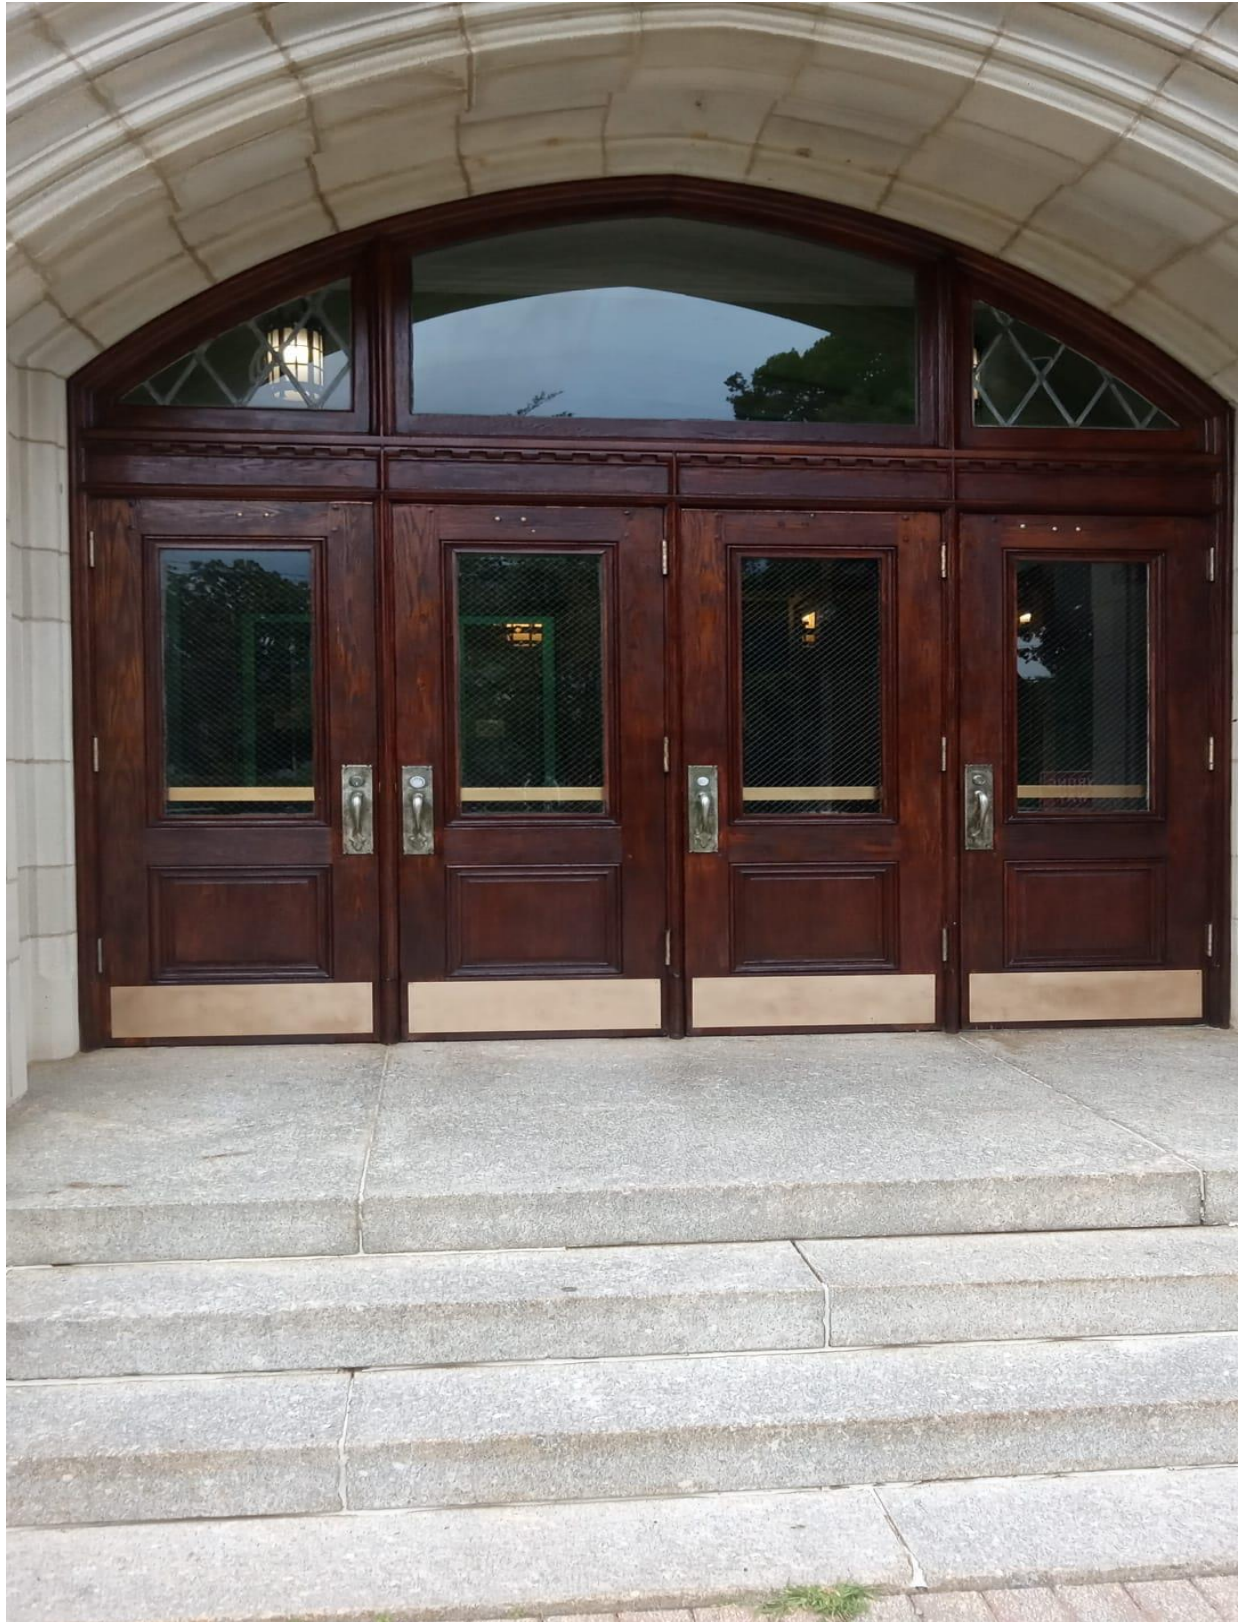
Doors number 1 and 2 in front of the High School

These doors have been sanded down, stained and a coat of polyurethane applied. In addition, the Plexiglas above both doors have been replaced with glass, damaged molding around the door window panes repaired and hardware removed, buffed to restore its original appearance. These repairs restore the doors to their original condition and also protect them from elements, thus extending their life.

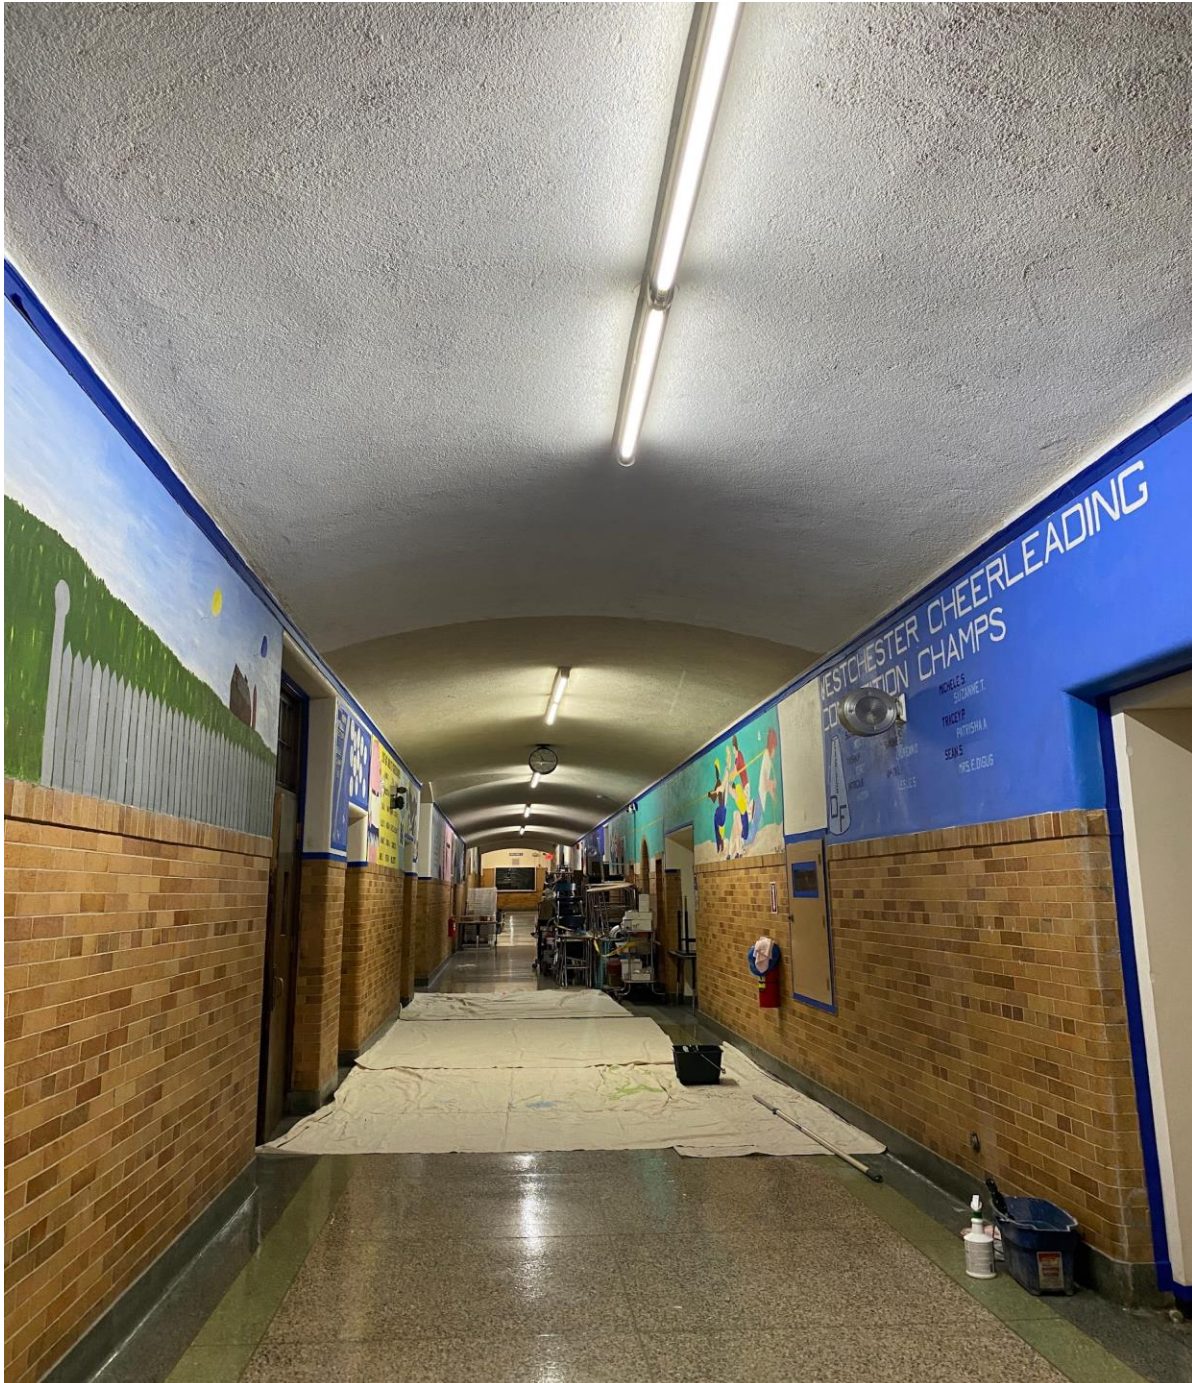
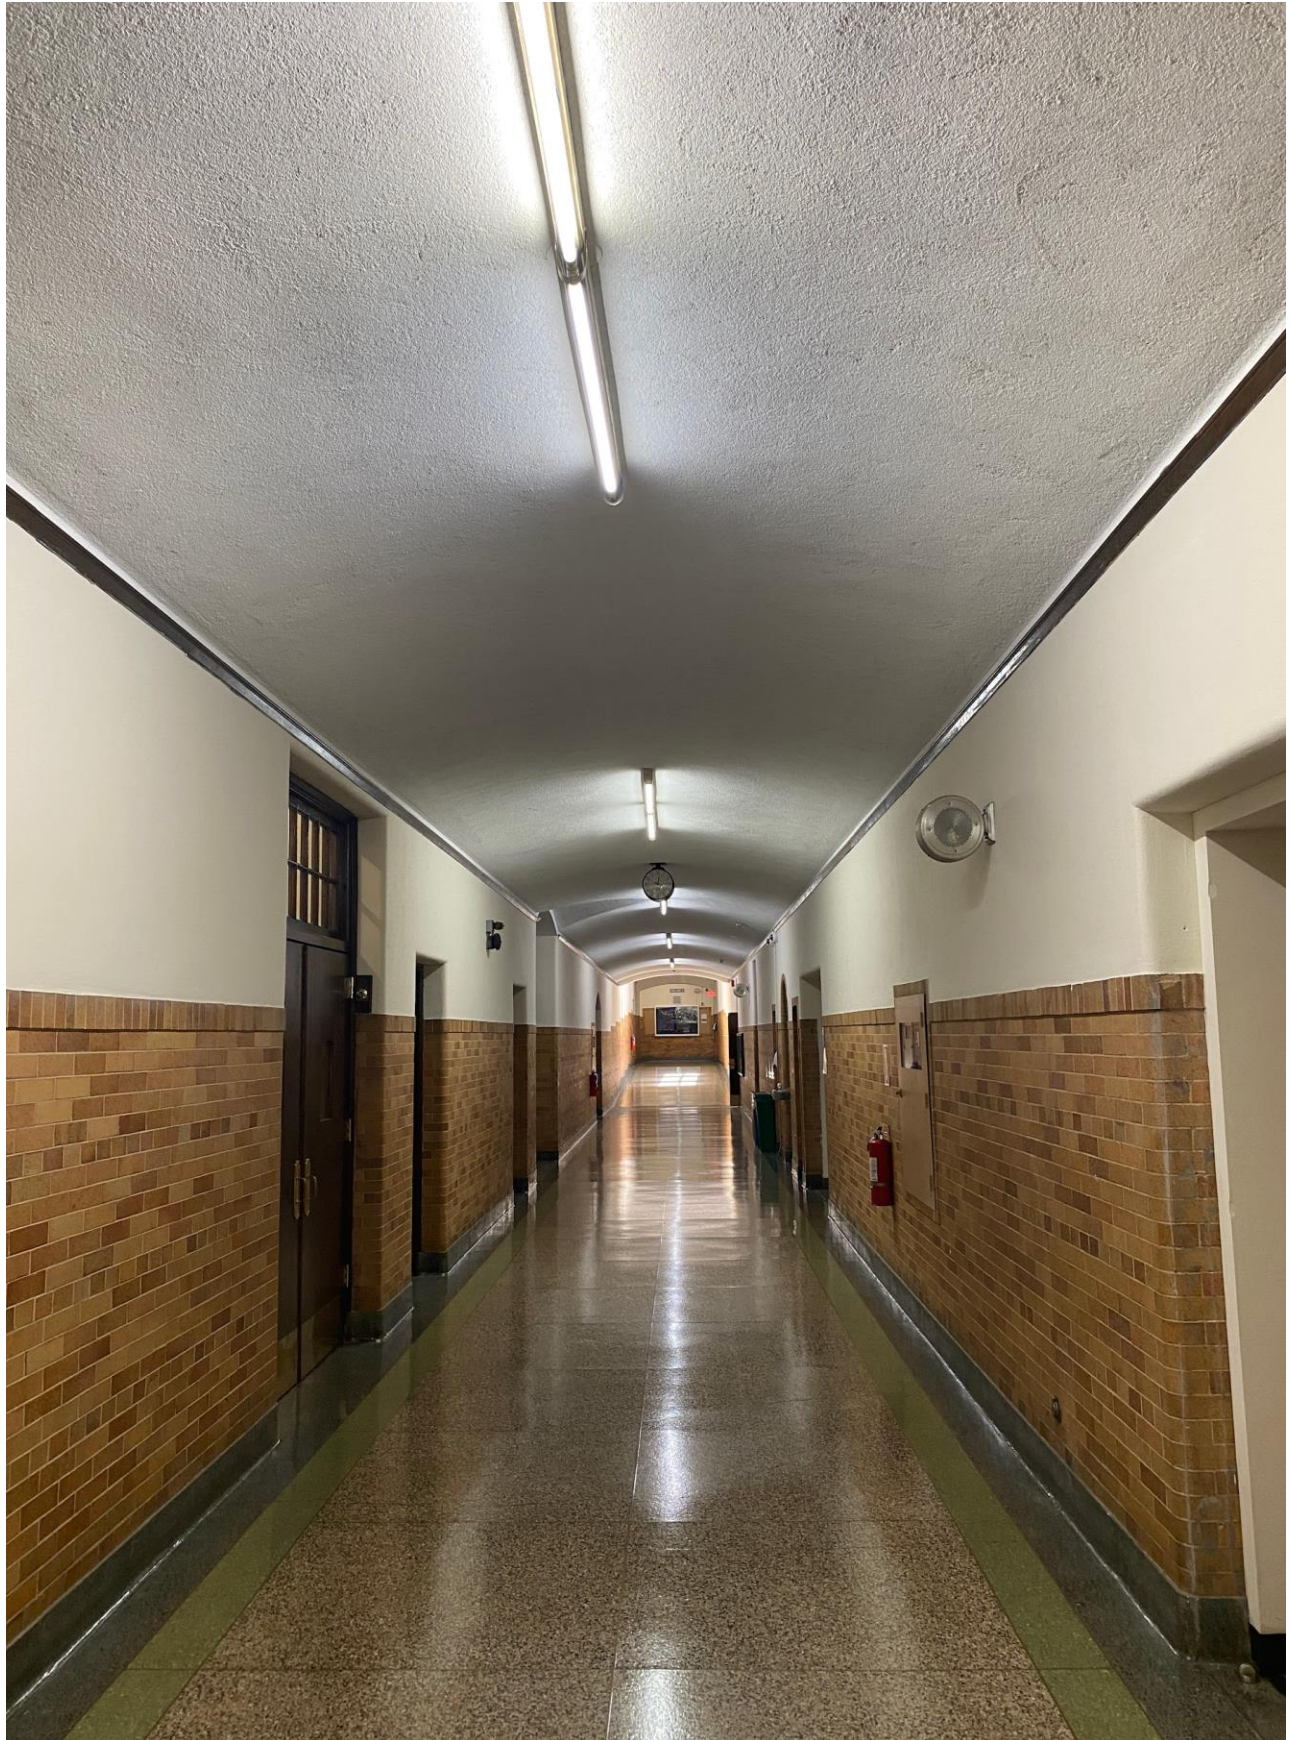
1st, 2nd and 3rd Floor High School Hallway Walls

The High School murals were scraped, walls primed and painted. The hallways now appear much brighter and will be easier to maintain in the future.

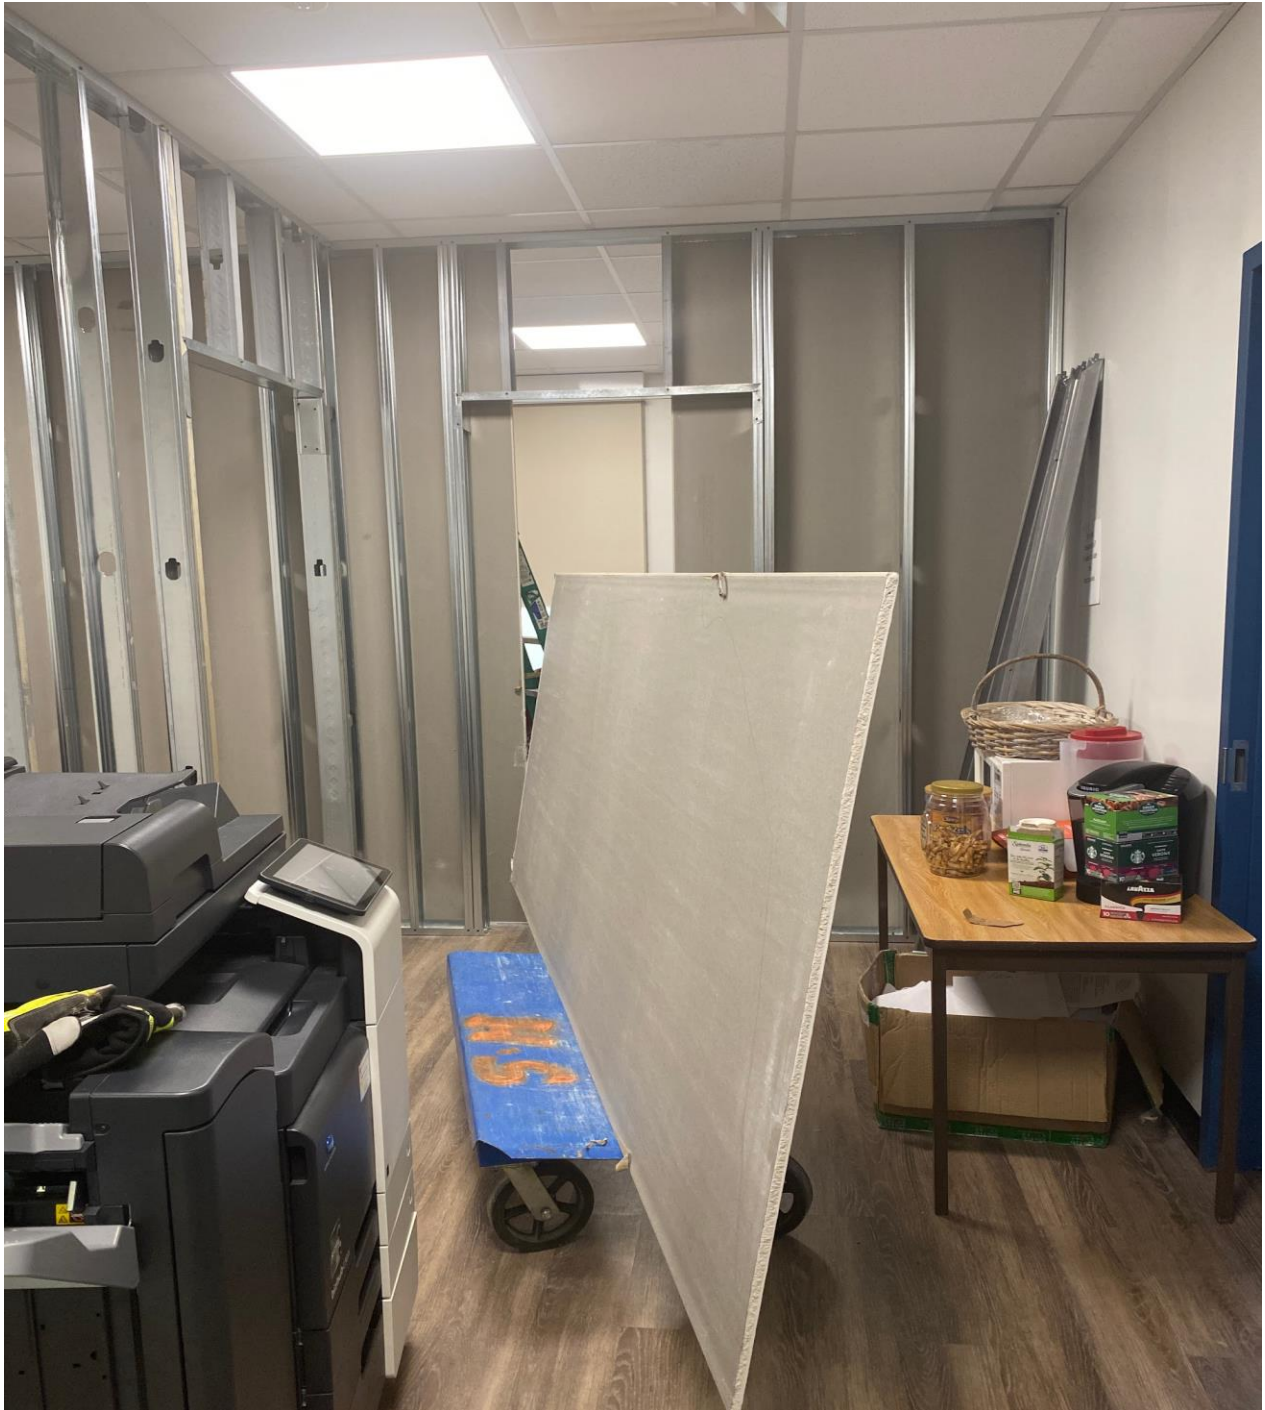
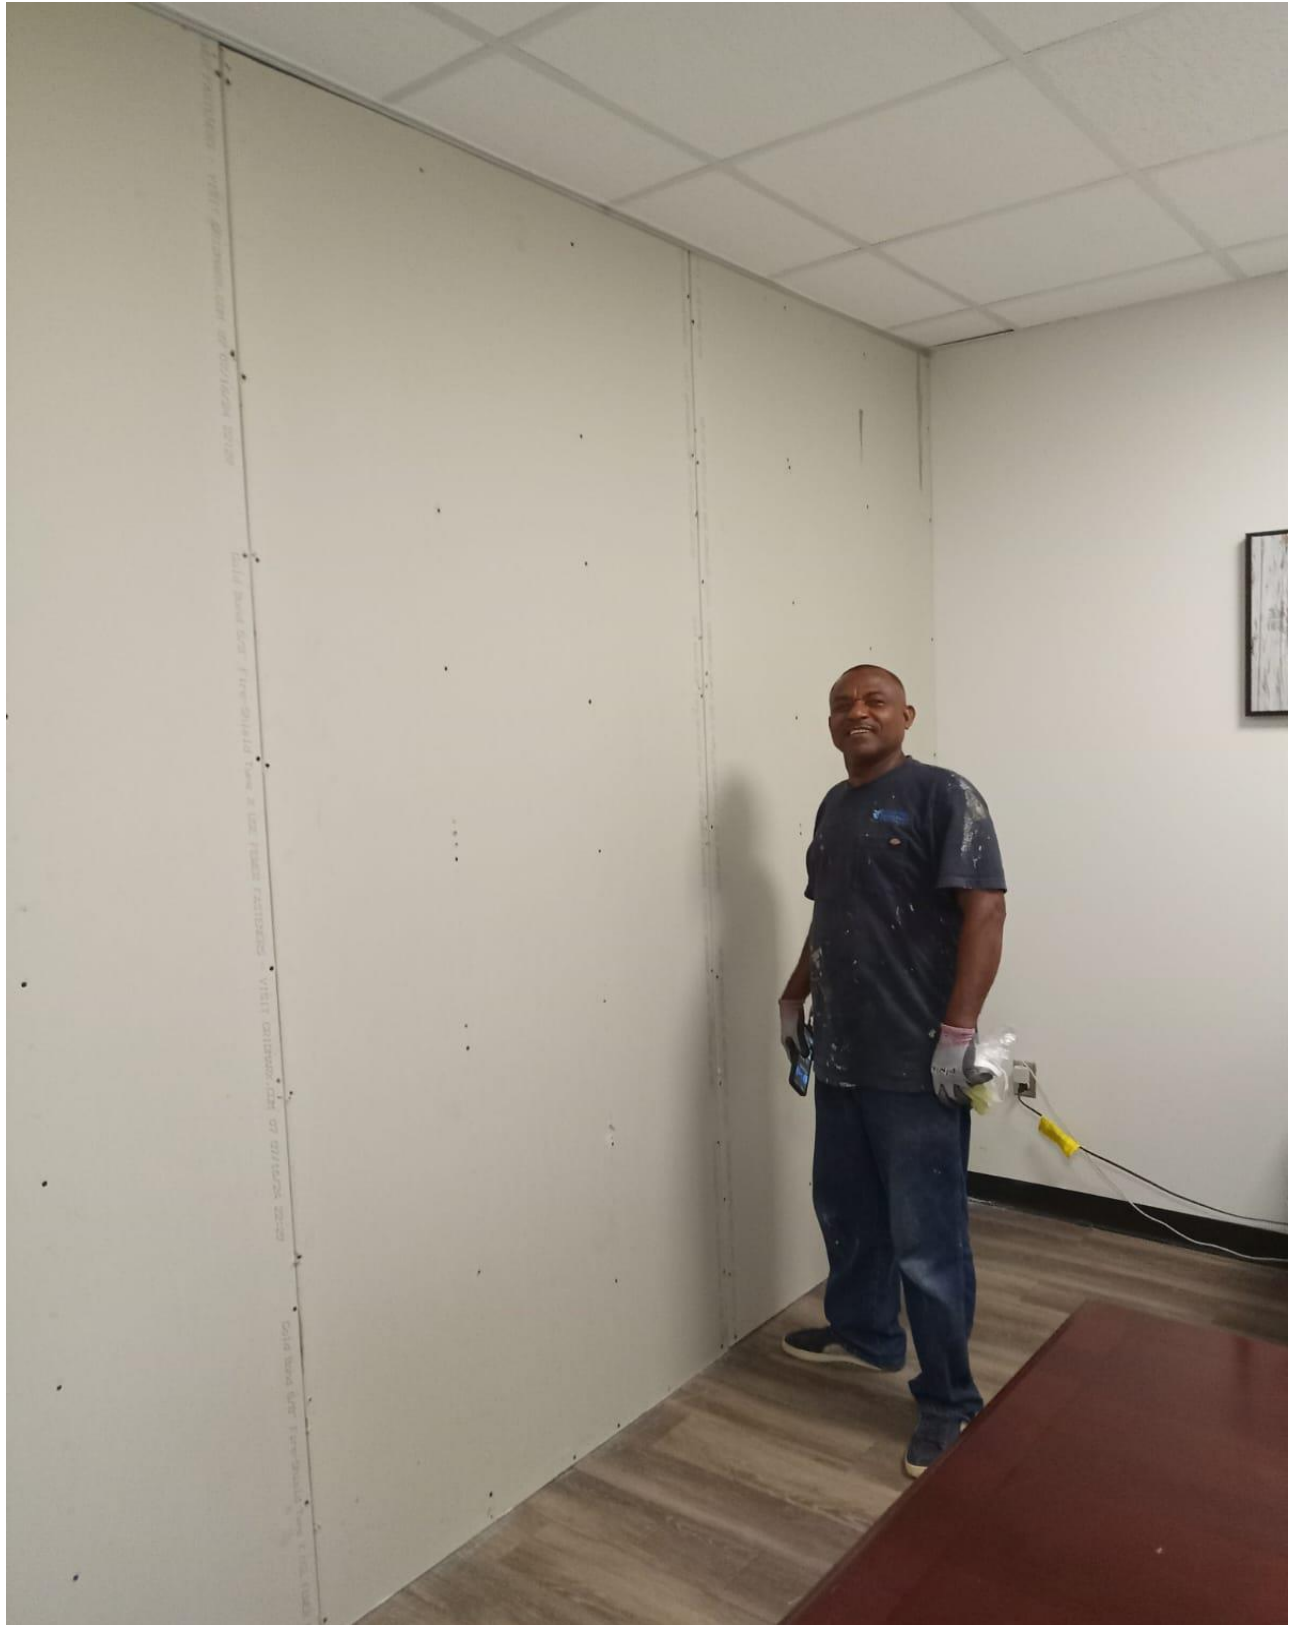
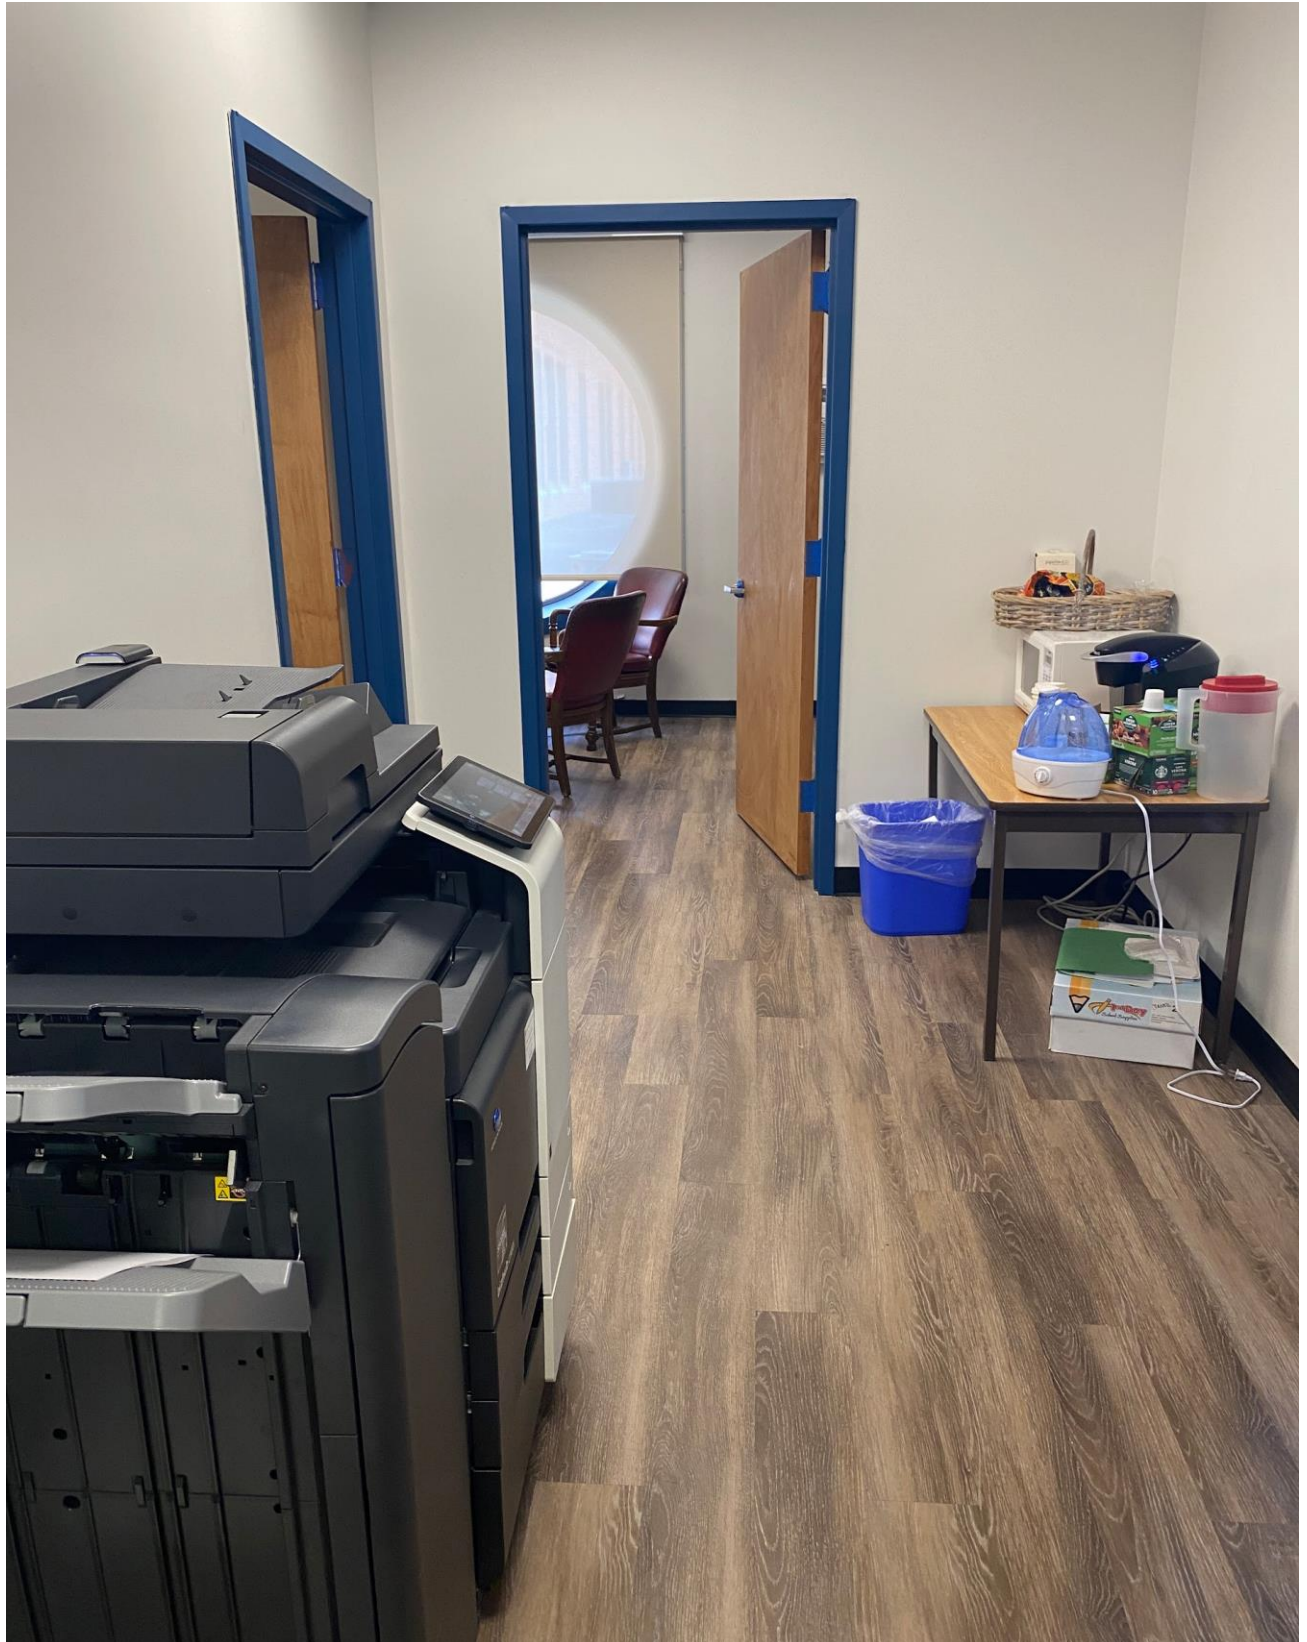
Special Education Office 200A/B (Middle school)

The prefabricated wall separating the Director of Special Education and the larger suite was removed and replaced with an insulated sheetrock wall. In addition, a wall was built in the common area of the suite to create an office for the CSE chair. Ventilation was also added to the new space.

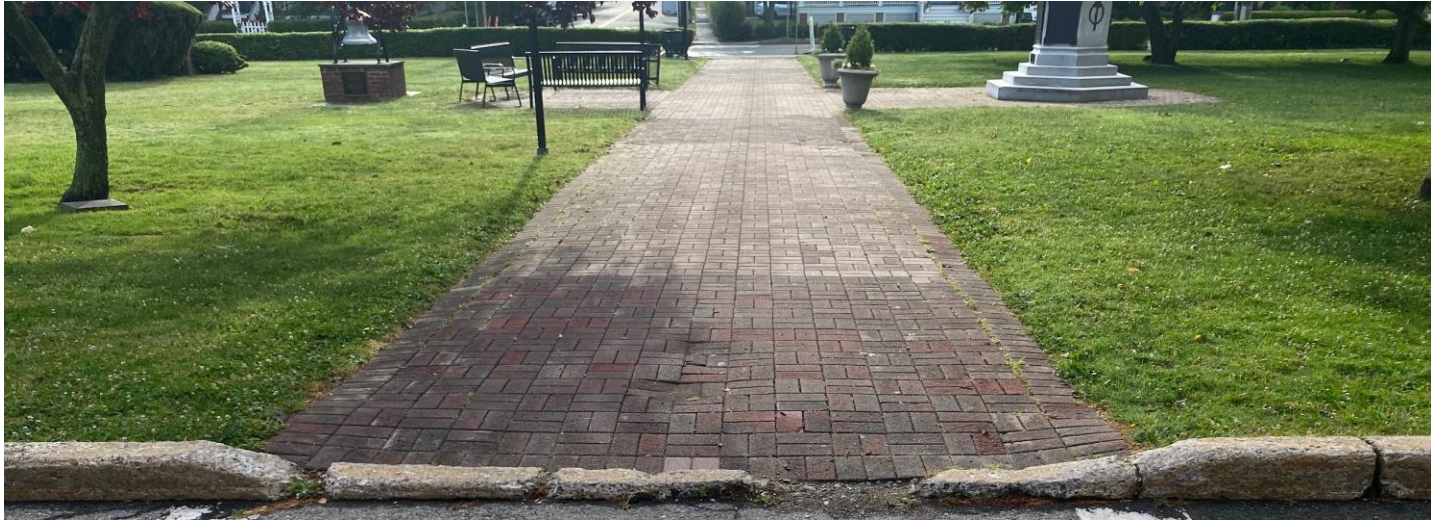
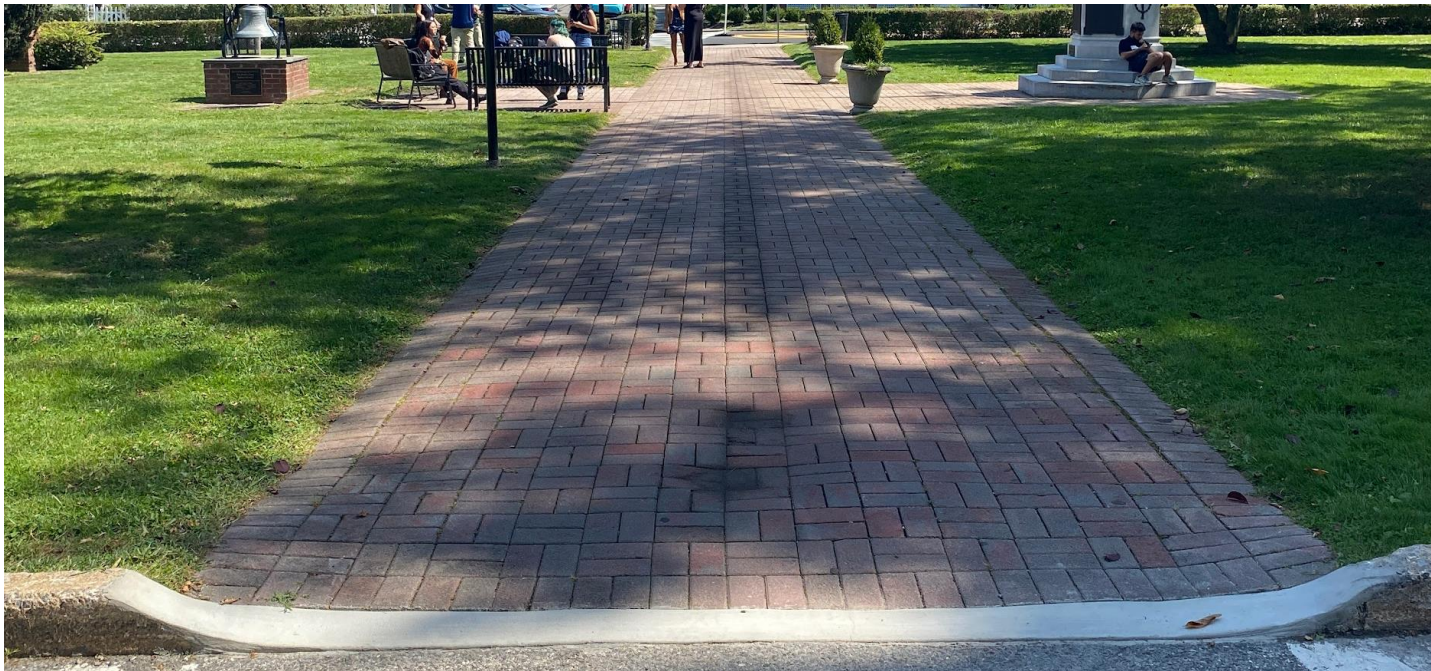
Front of High School by Flag Pole

The curb separating the pavers from the asphalt were cracked and raised causing a tripping hazard. The curb was removed and replaced with a new curb that is flush with the pavers and asphalt.
