Before and After

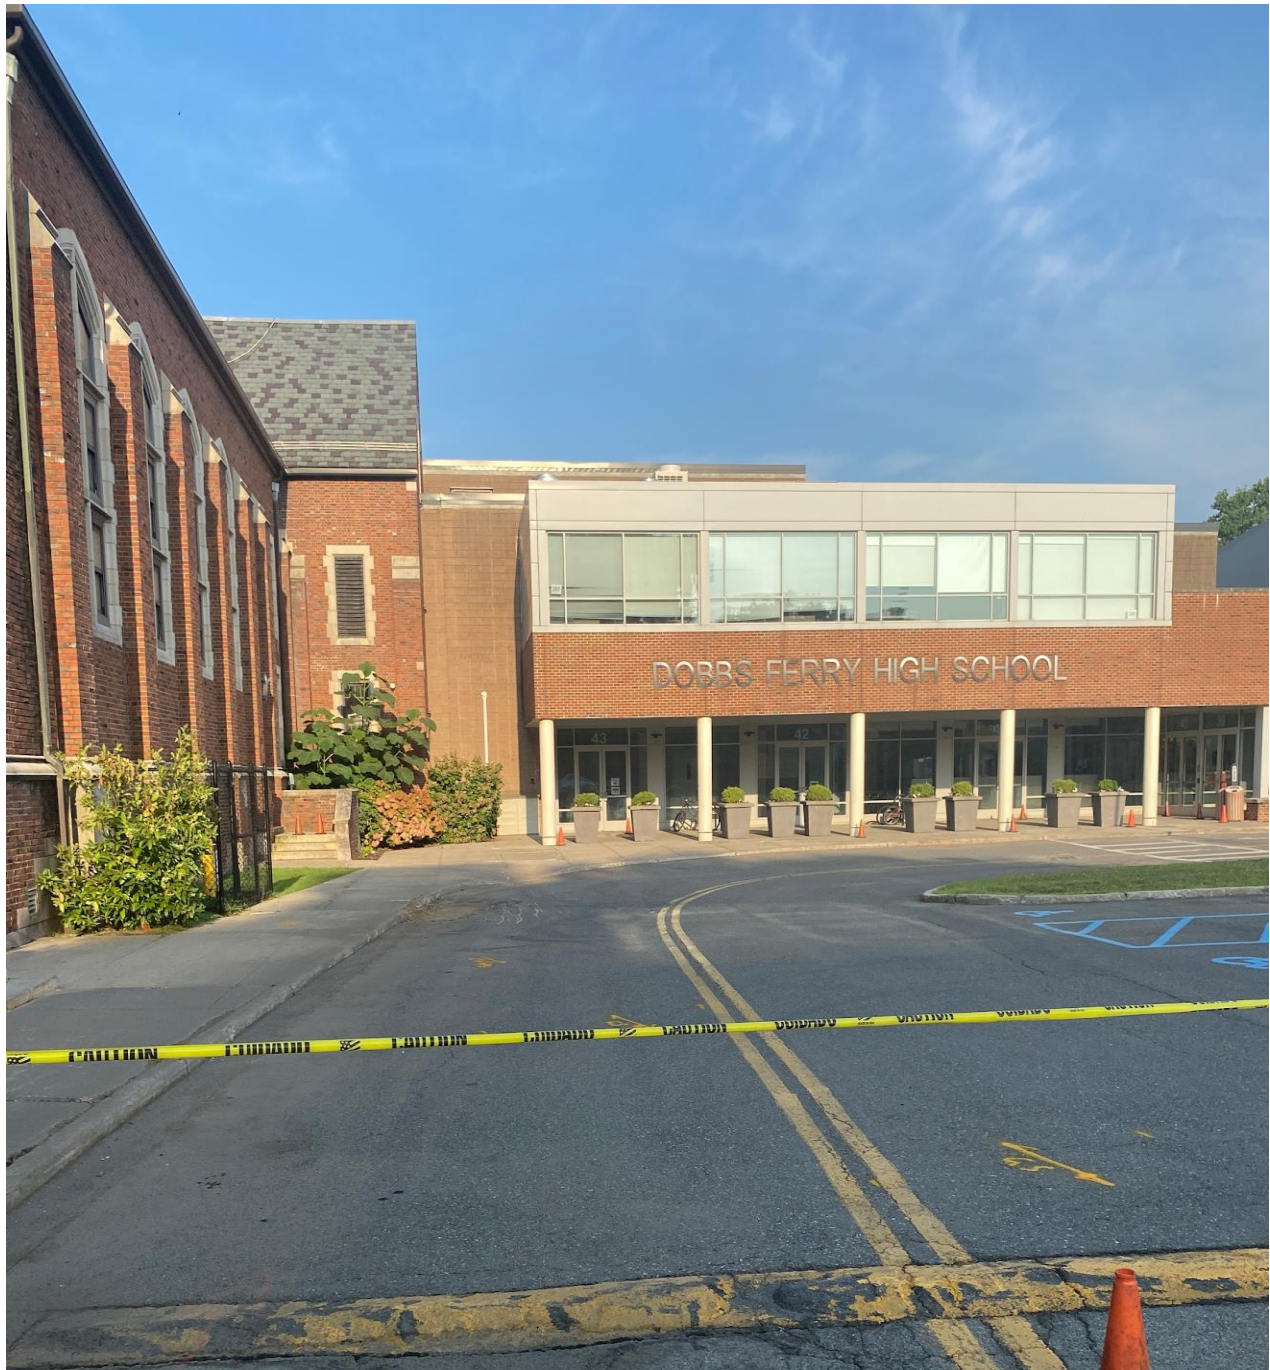
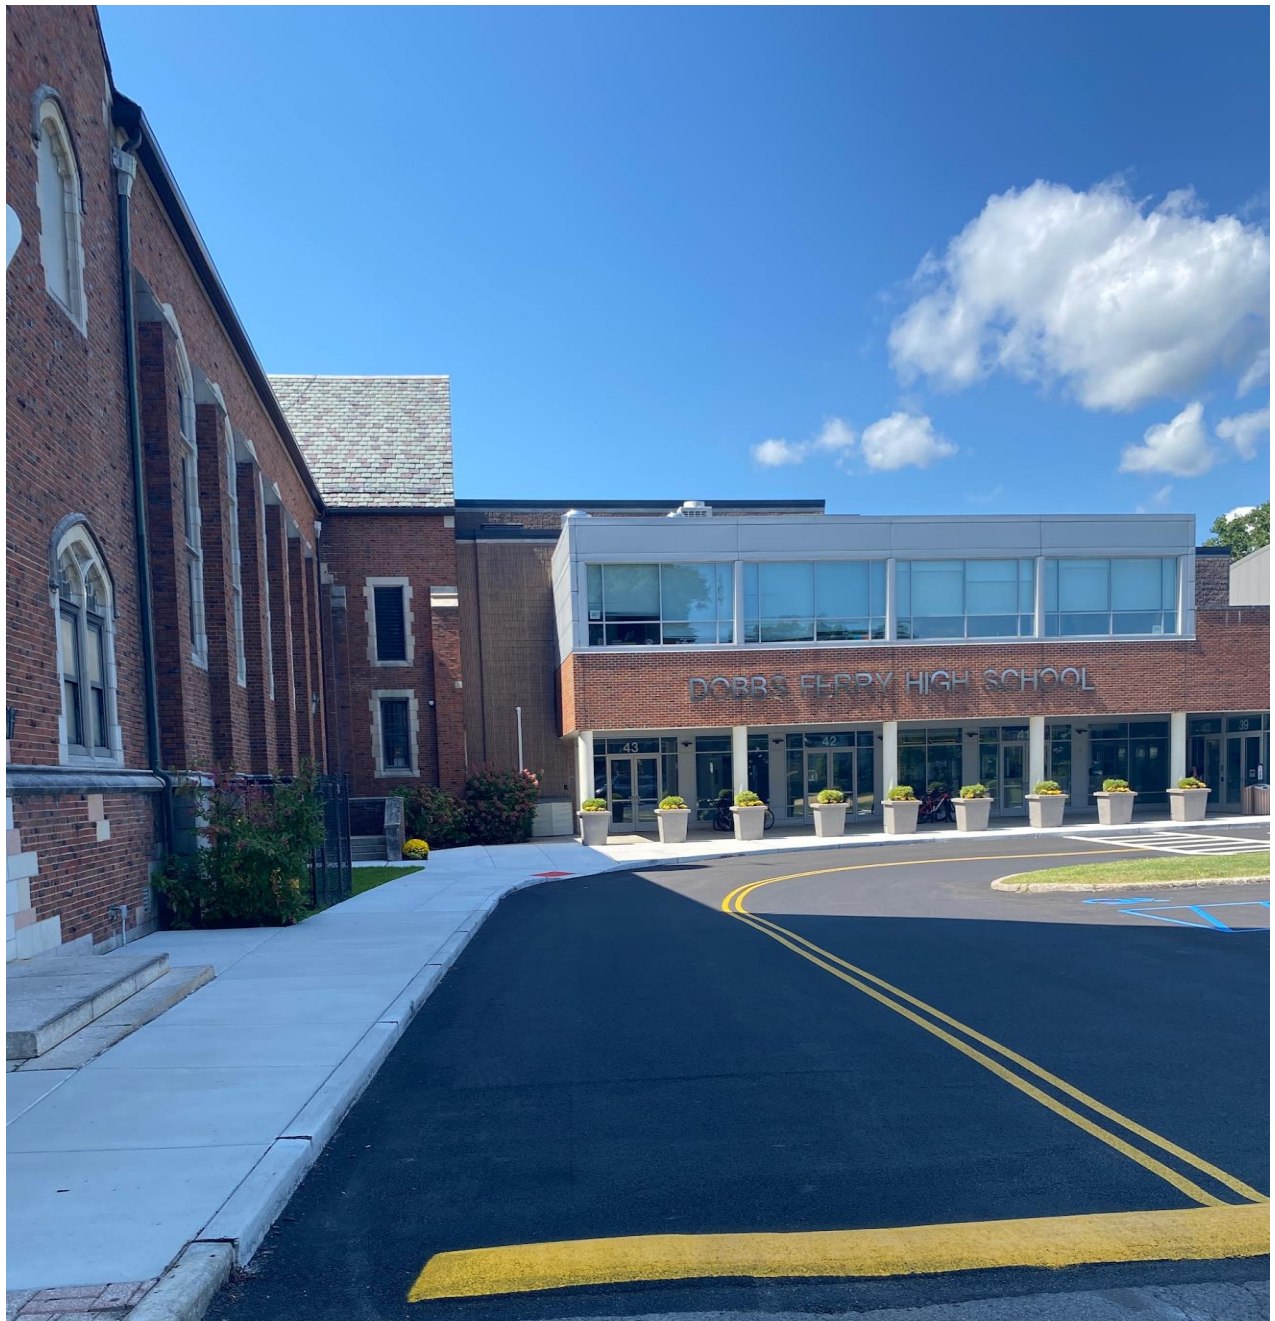
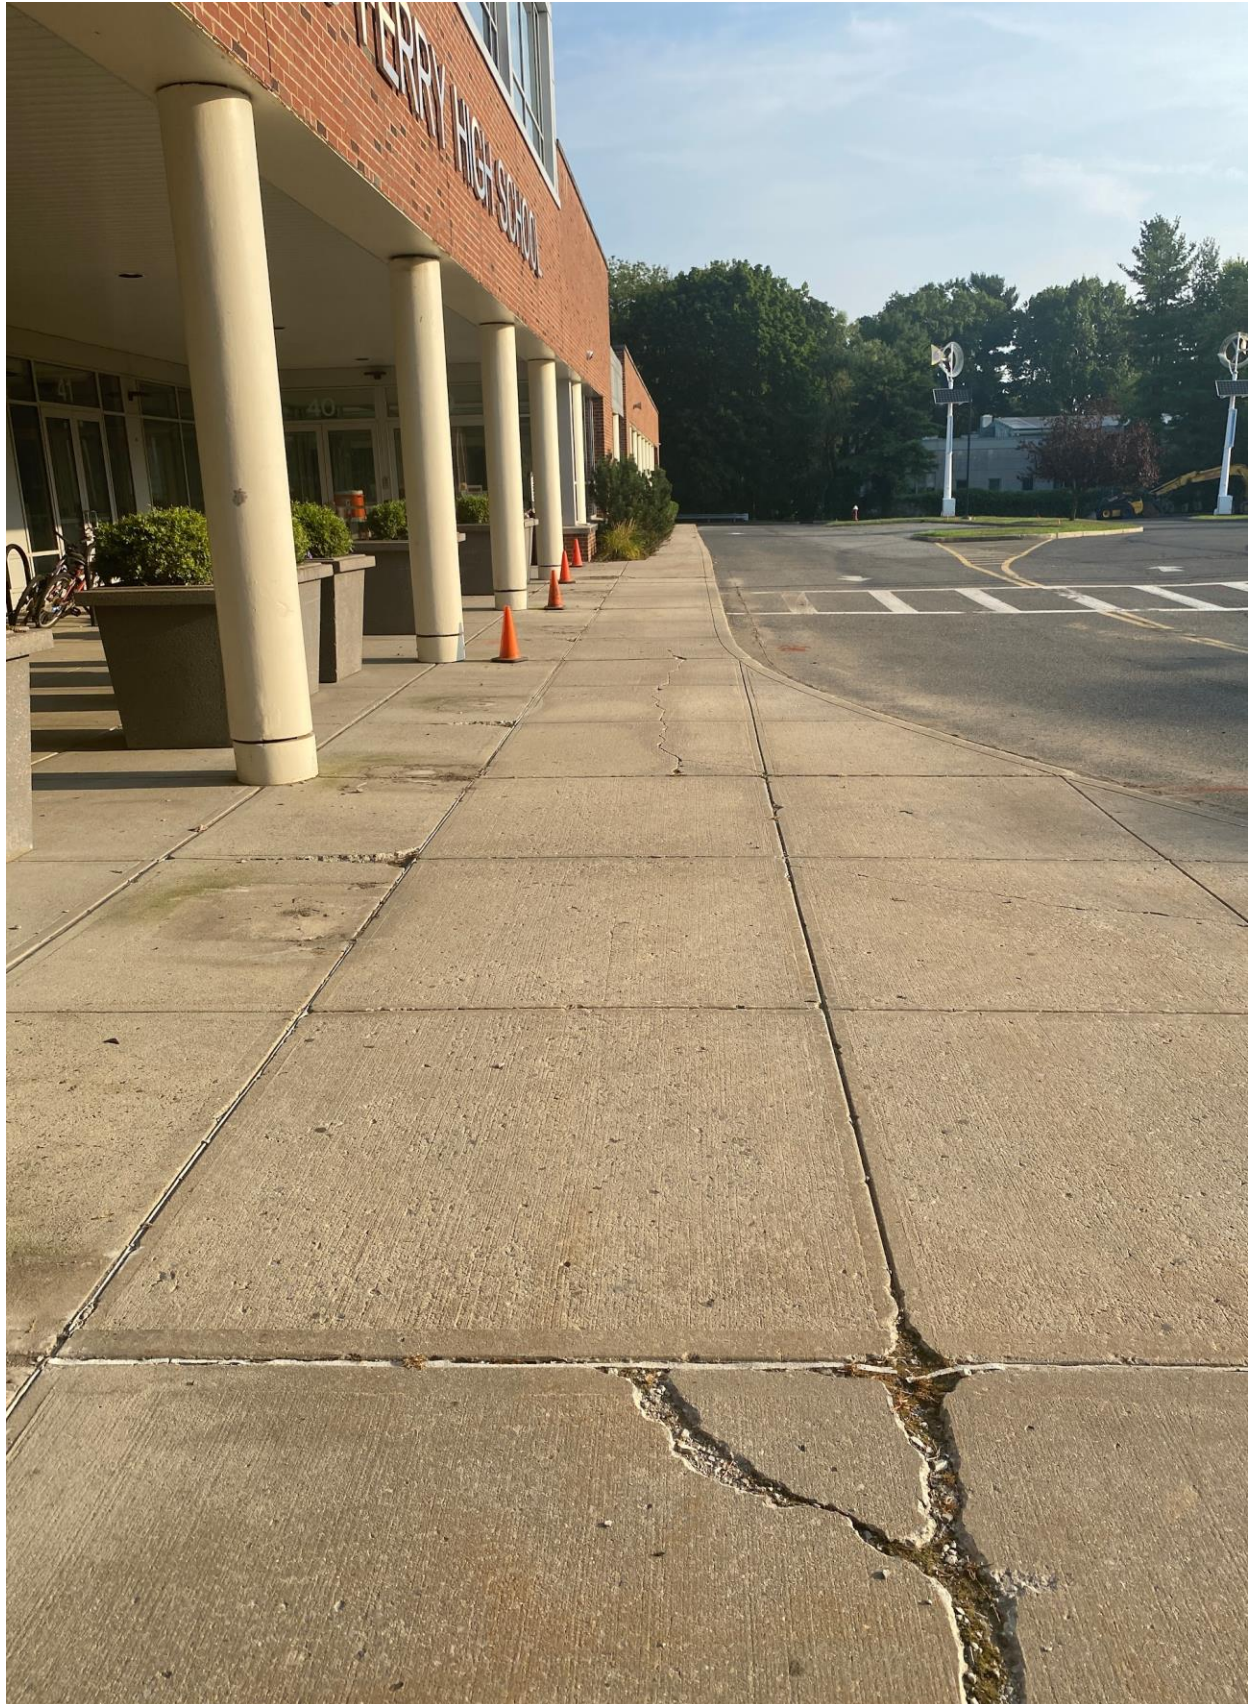
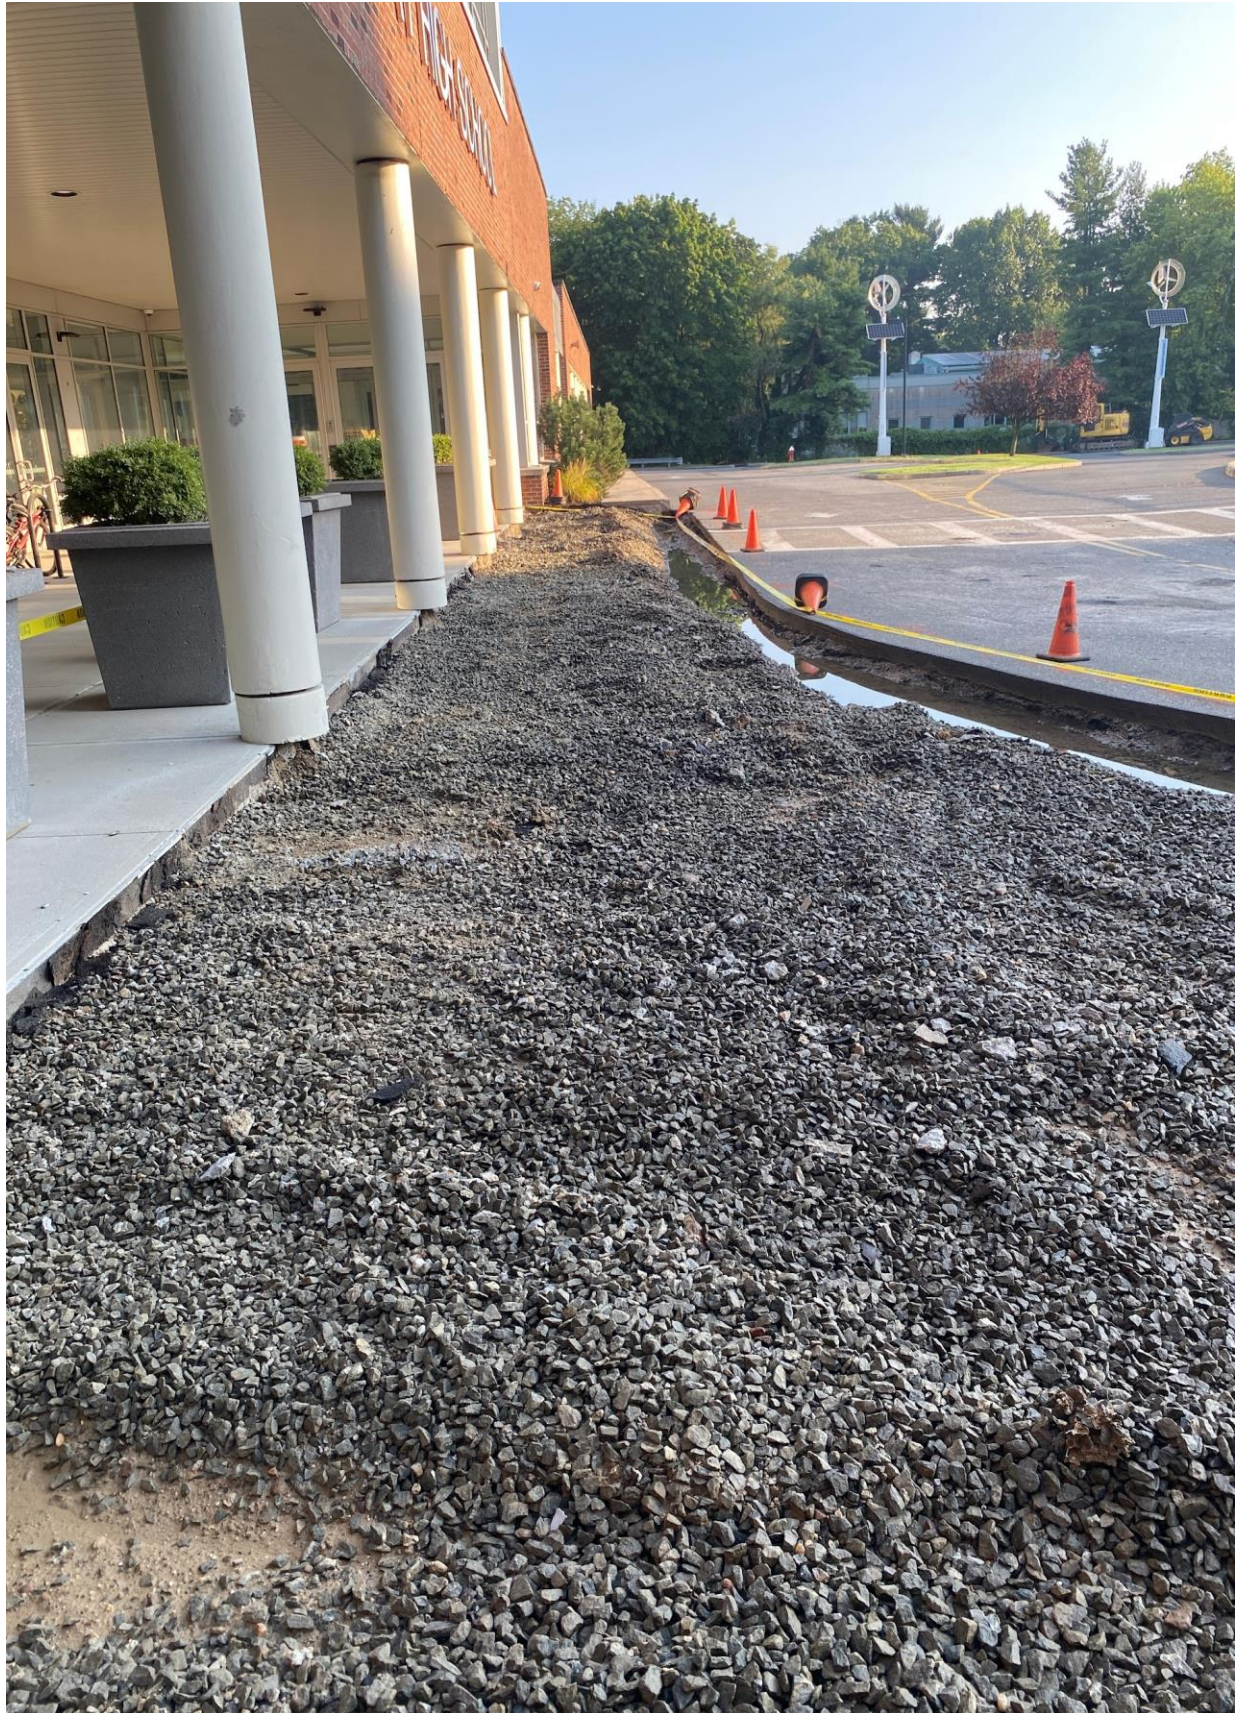
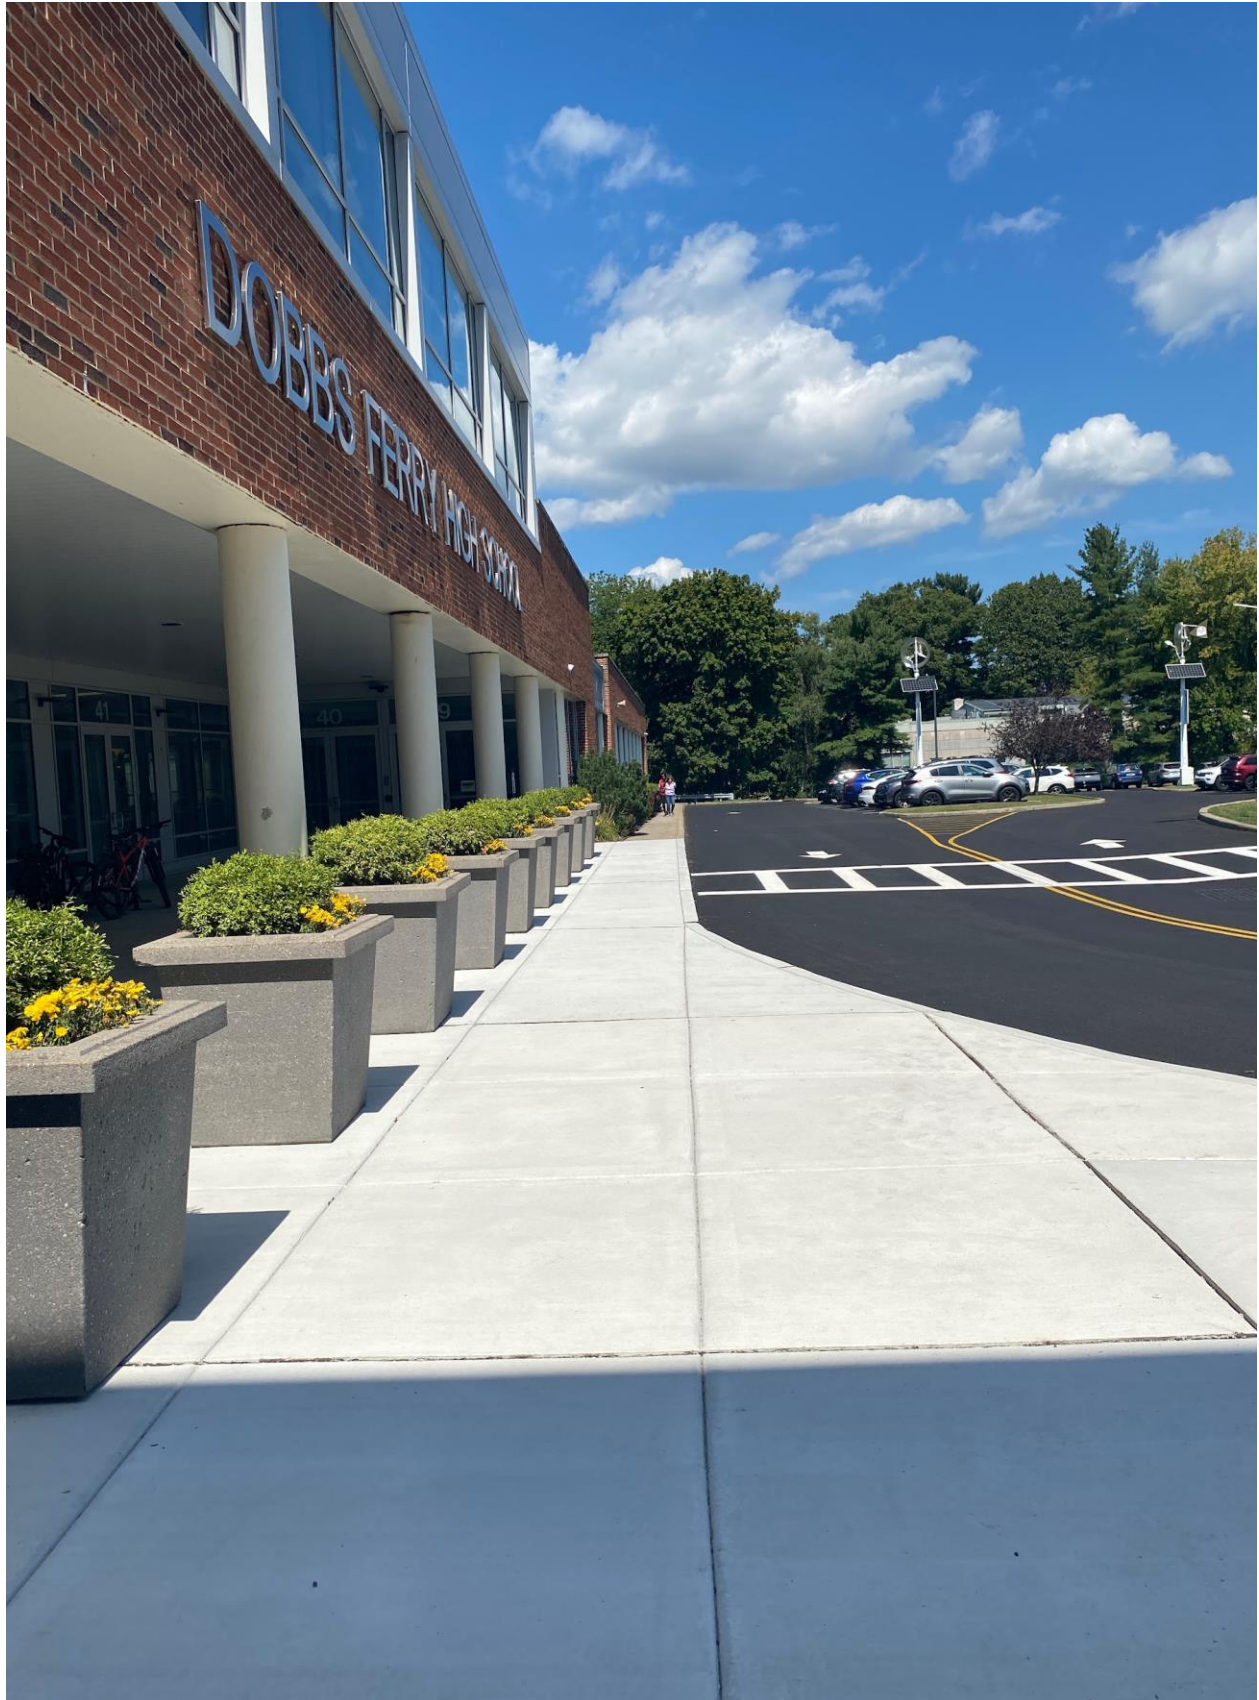
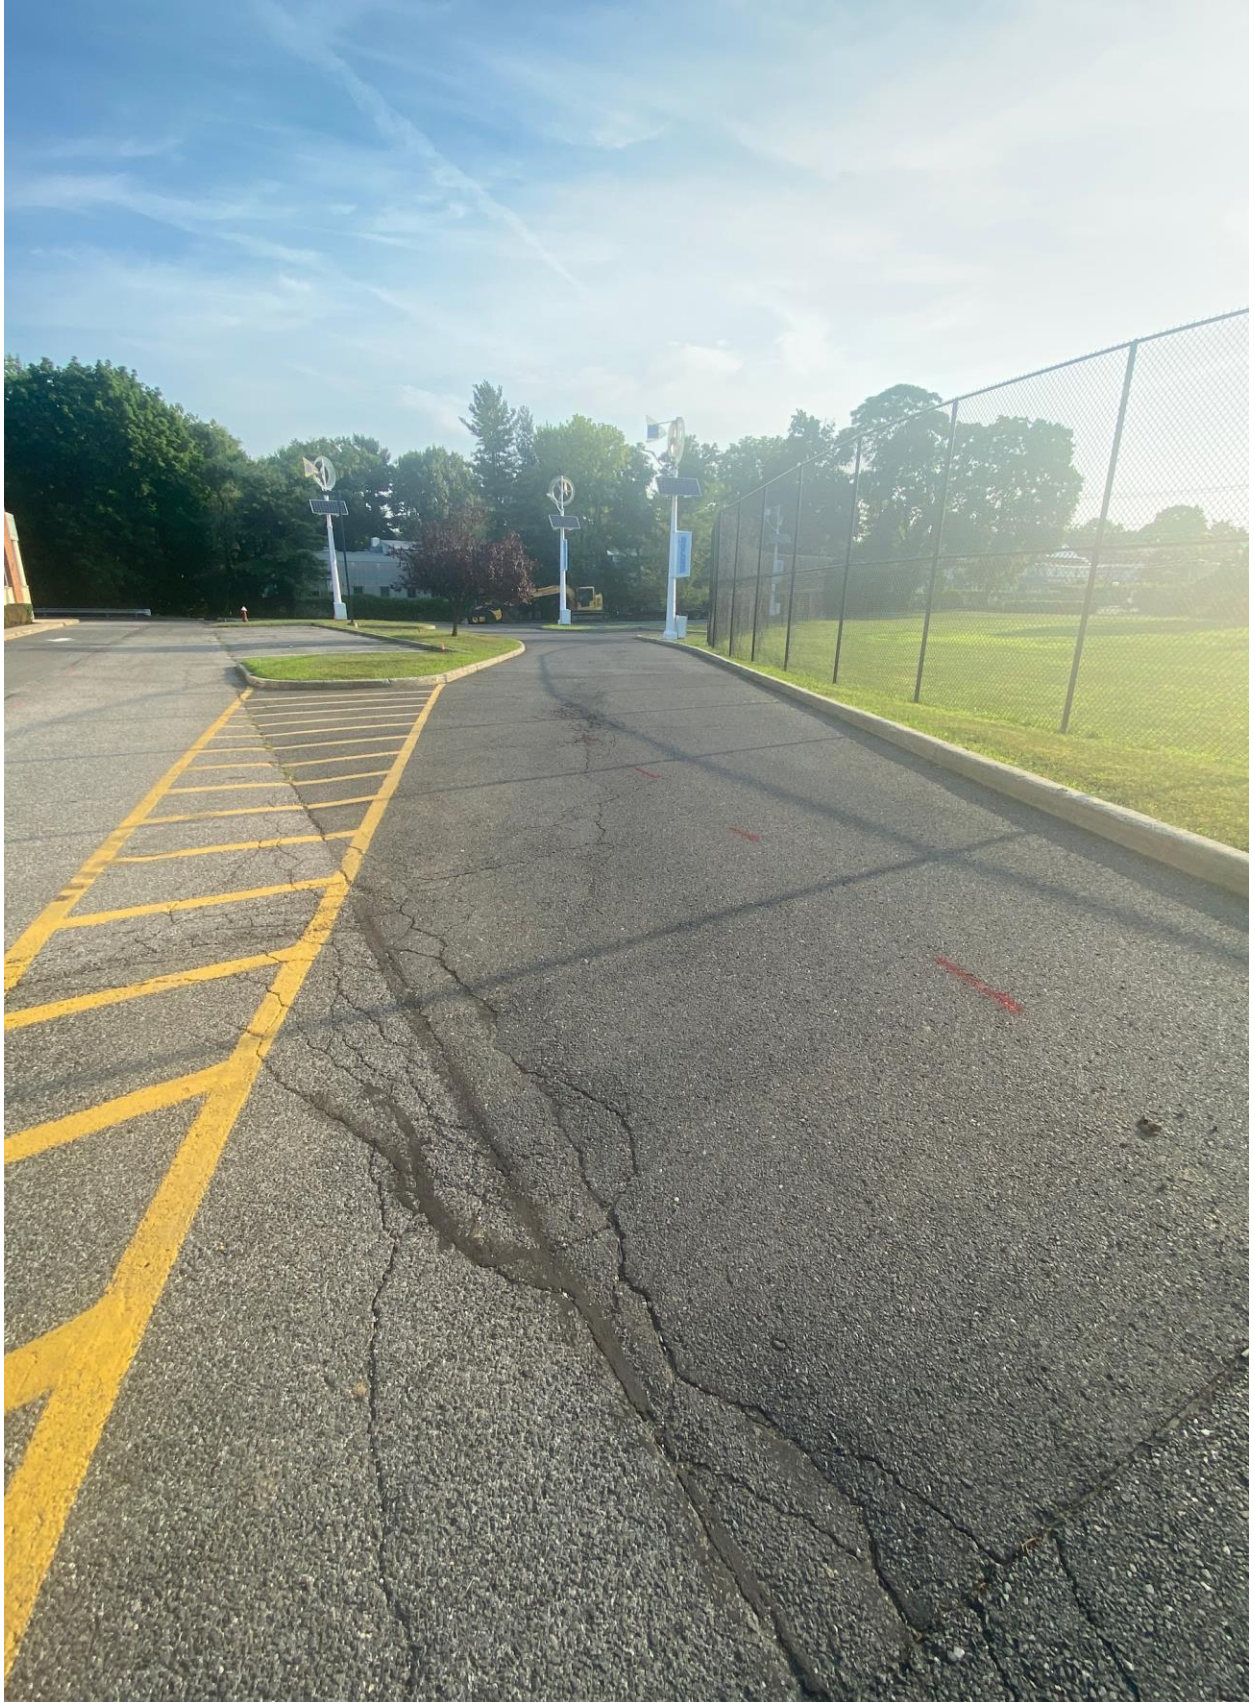
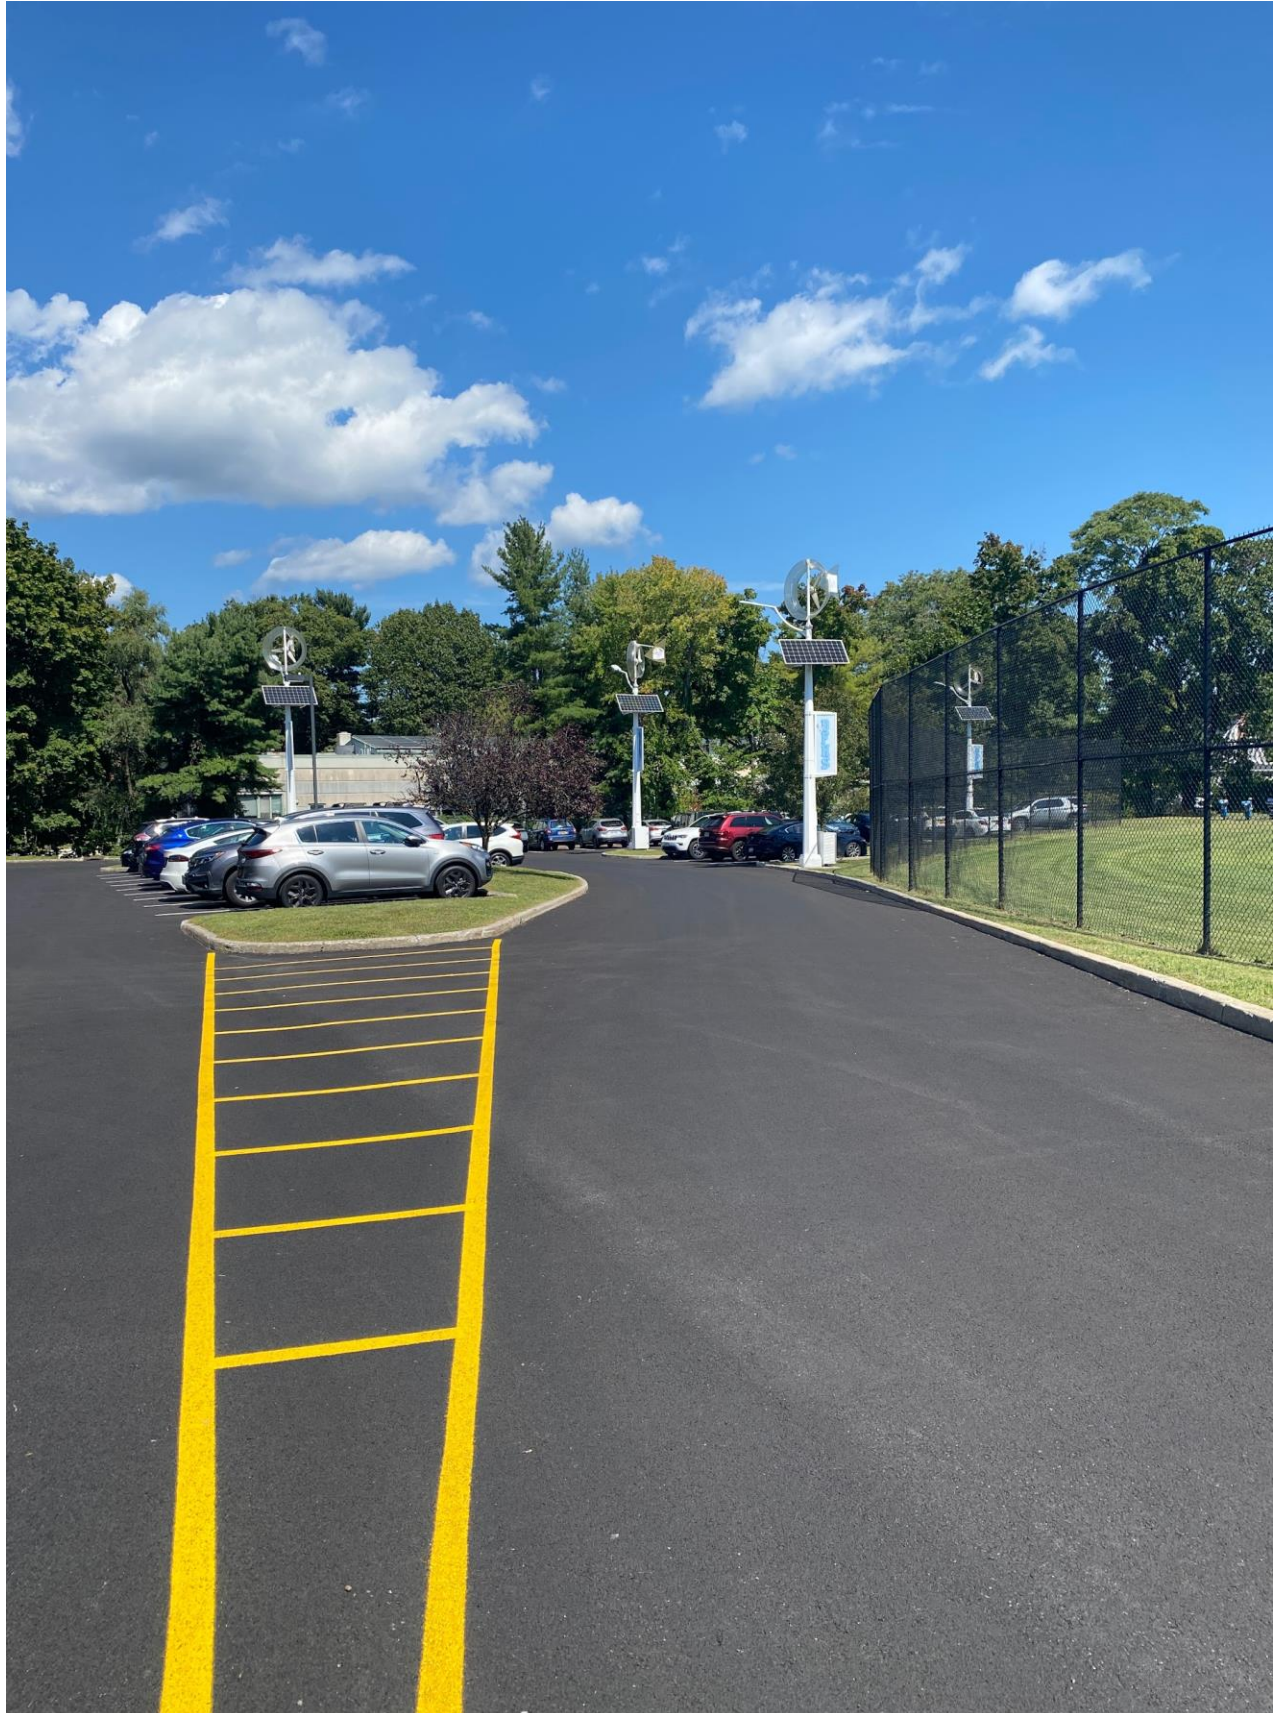
High School Parking Lot and Sidewalks

The High School sidewalks from the pavers to the front were cracked and uneven in areas causing tripping hazards. In addition, the parking lot had developed potholes and cracks. The sidewalks were replaced and the parking lot was milled, repaved, and lined.

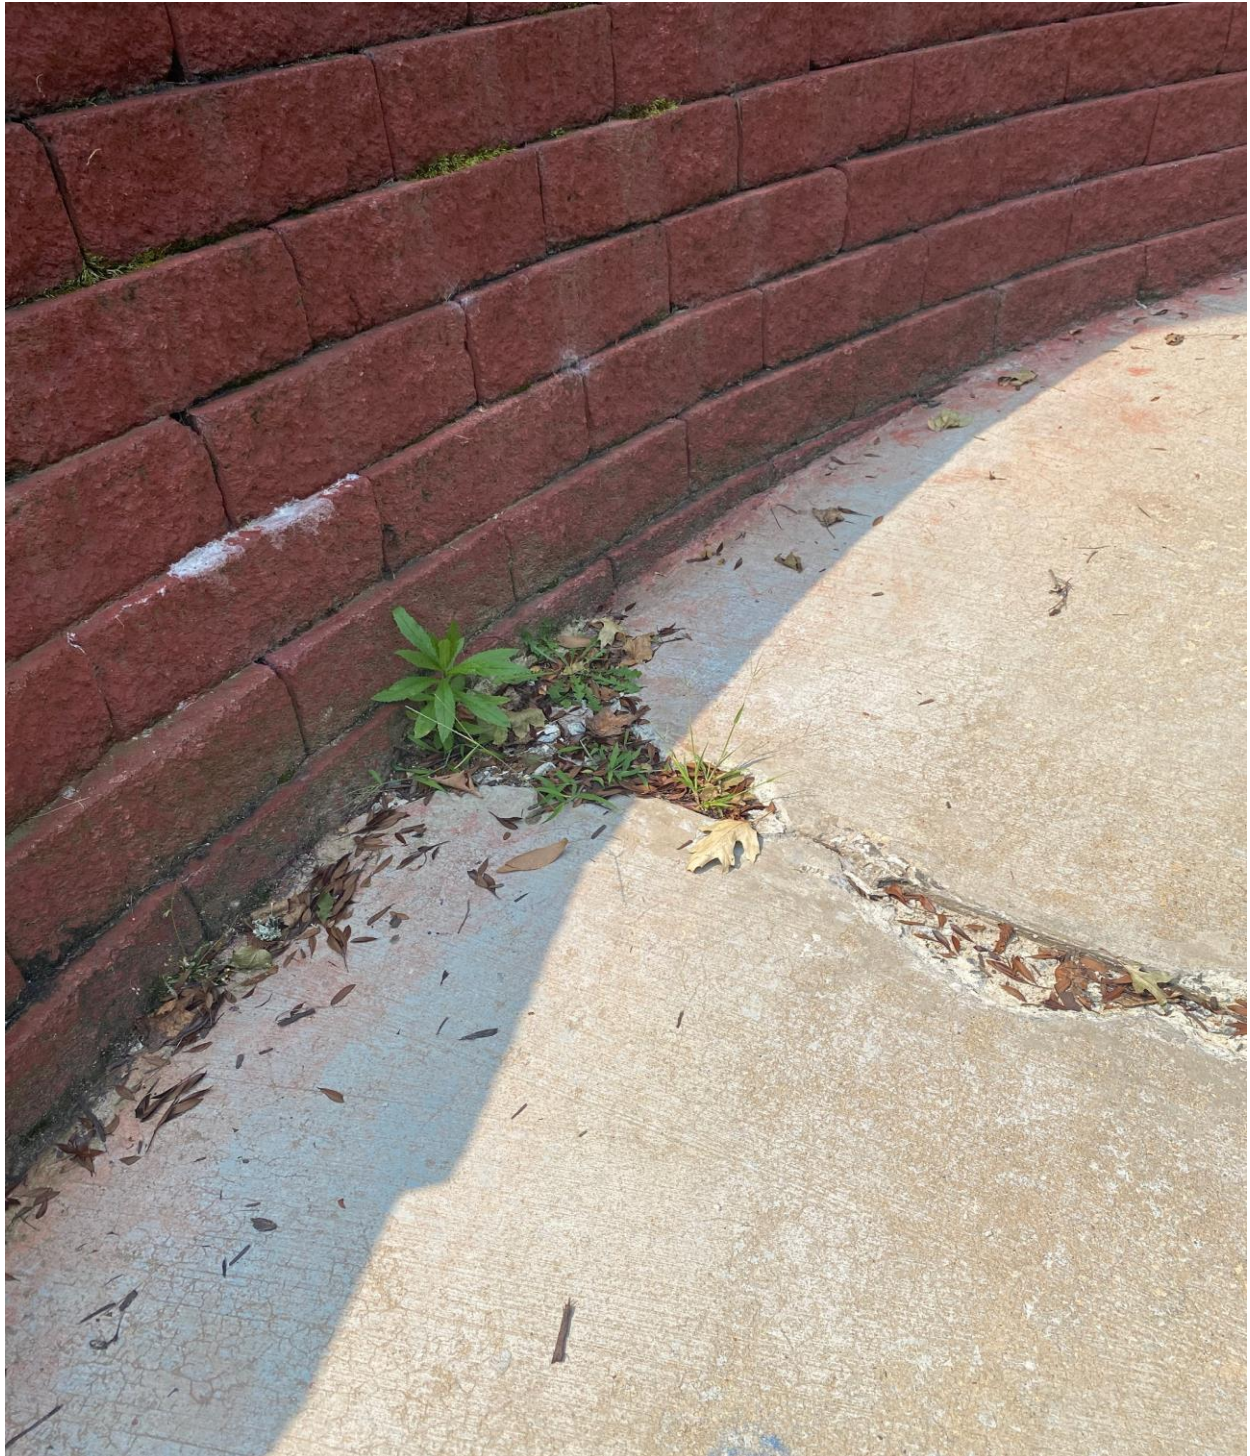
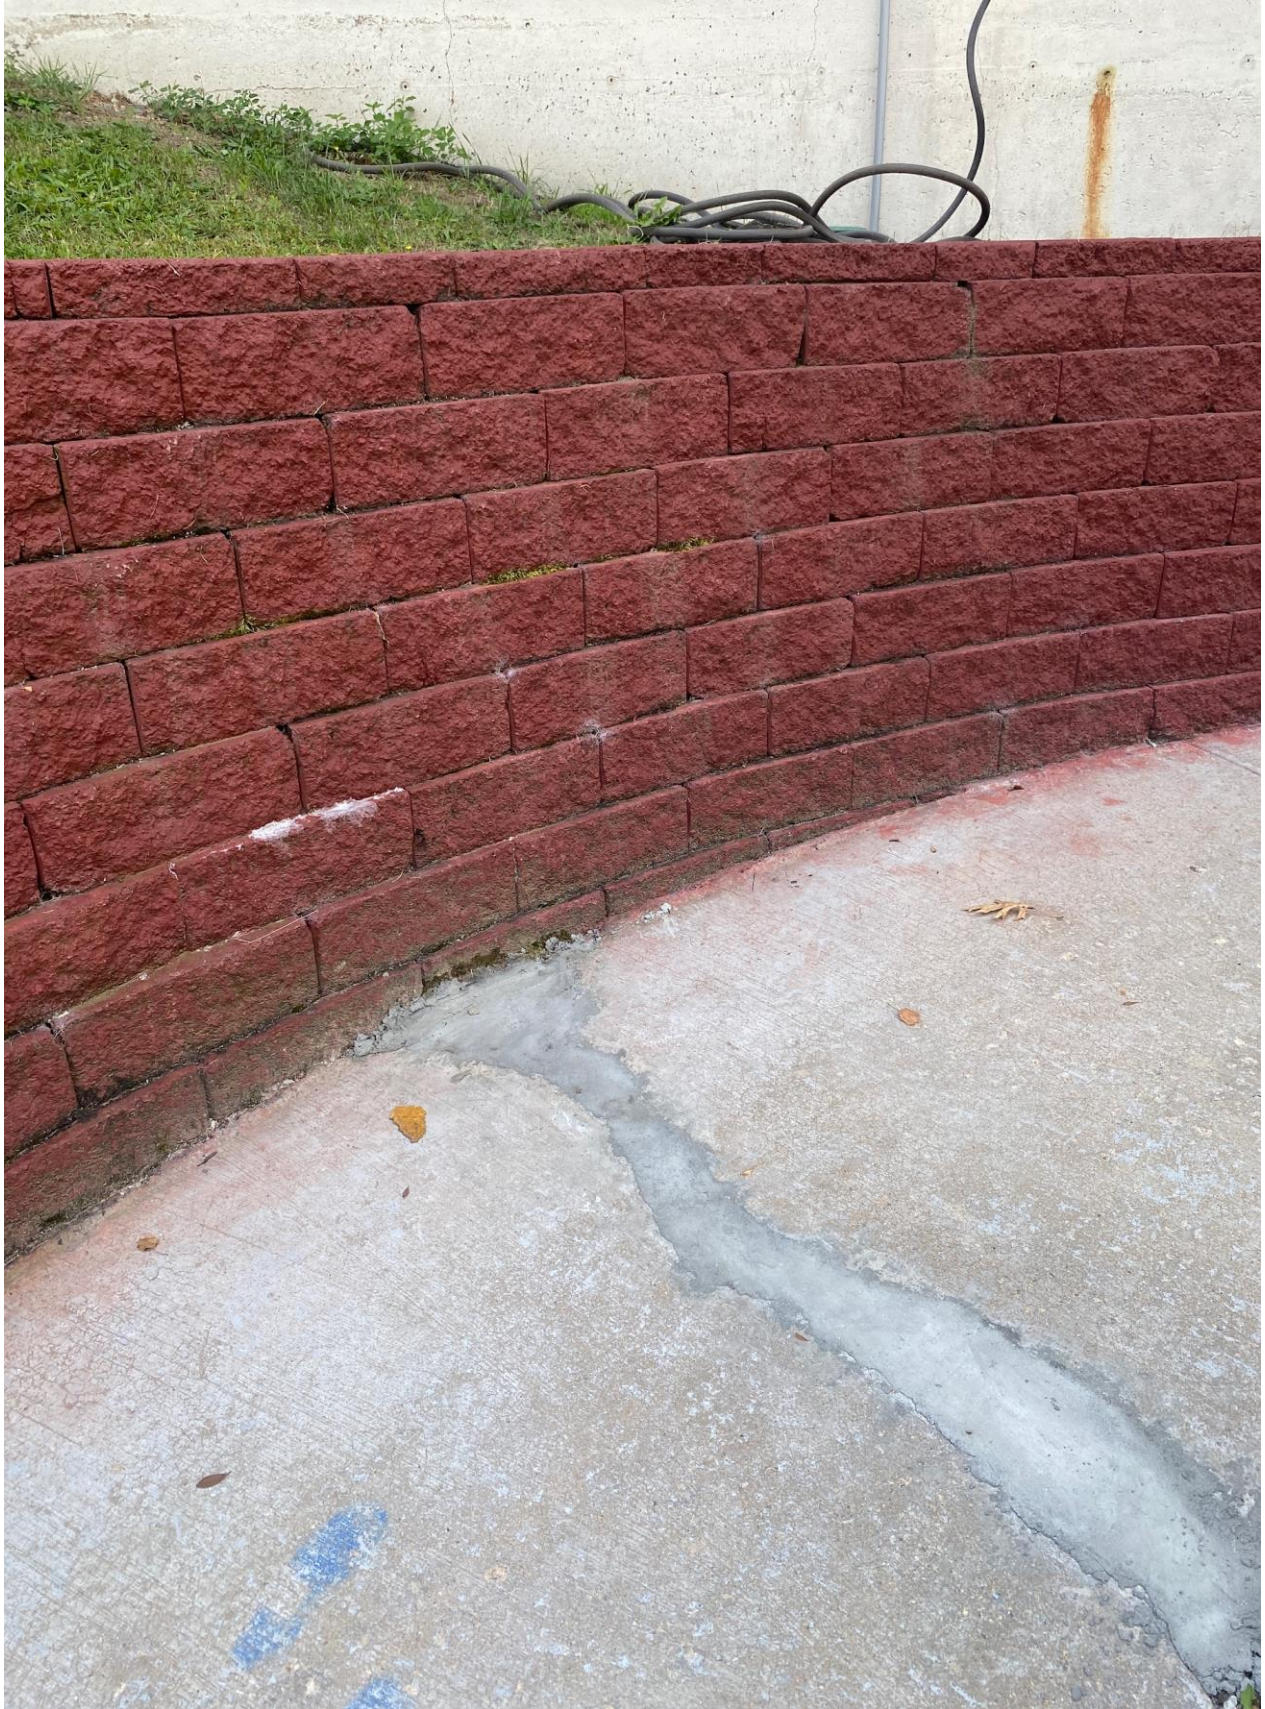
Springhurst Front Ramp and Sidewalk

Several minor concrete repairs were made to the ramp and concrete outside of the Springhurst front entrance. While these repairs fix tripping hazards, they are temporary and the sidewalk will need to be considered for replacement in the next several years.

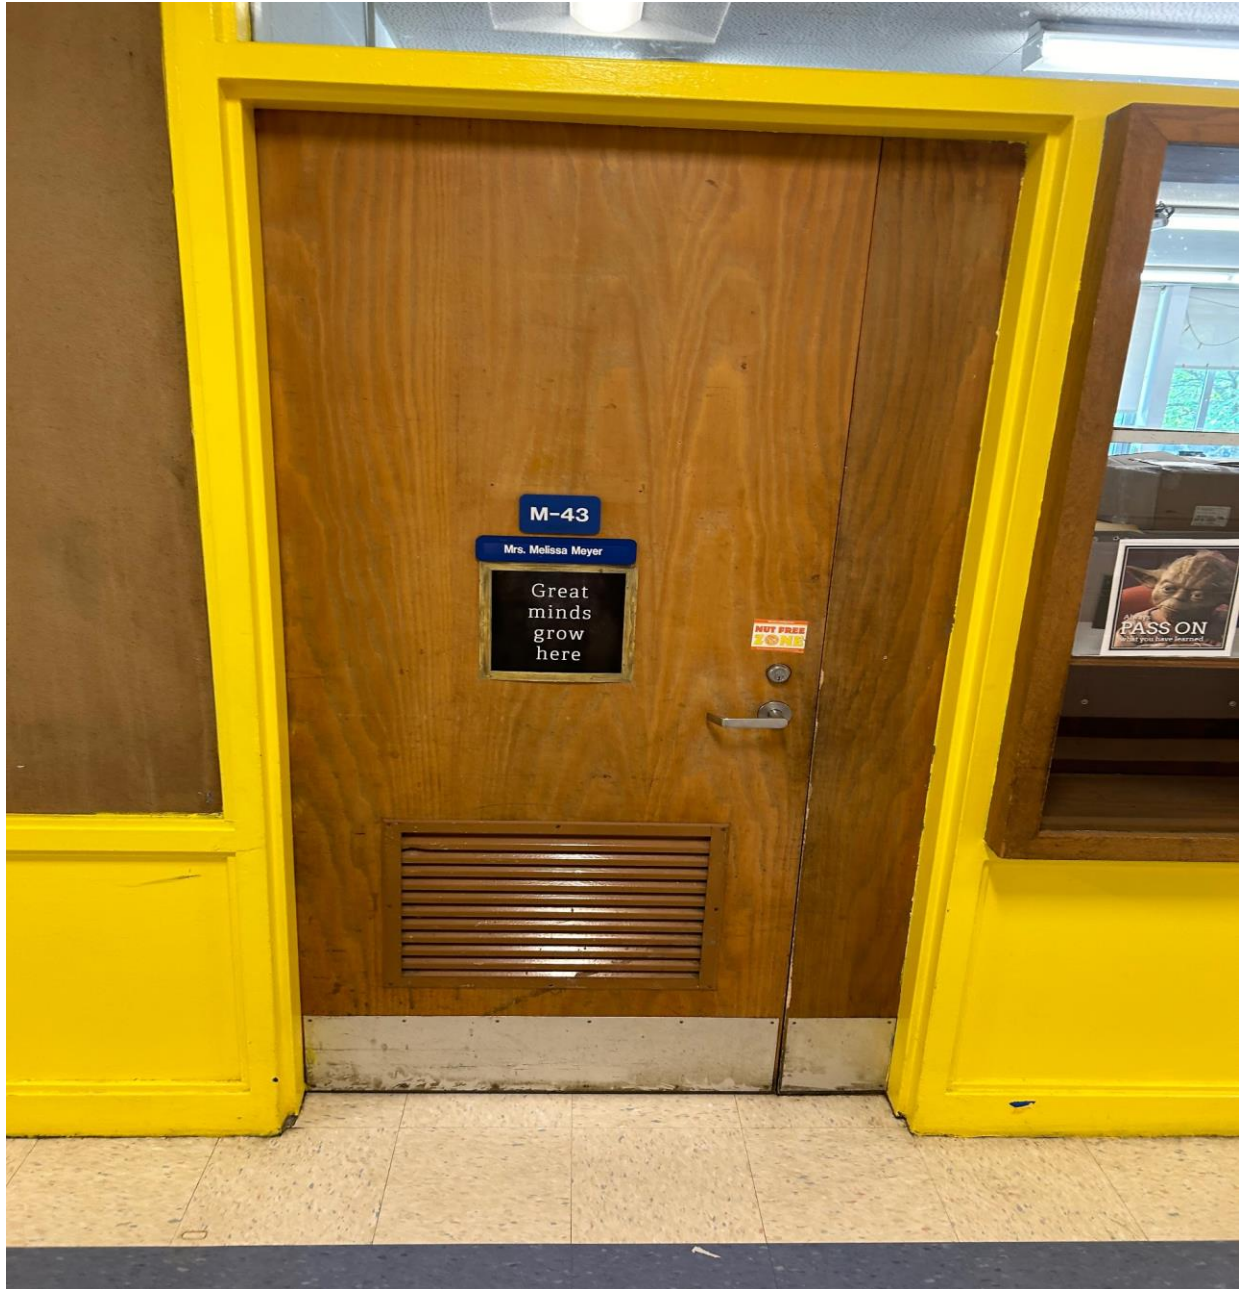
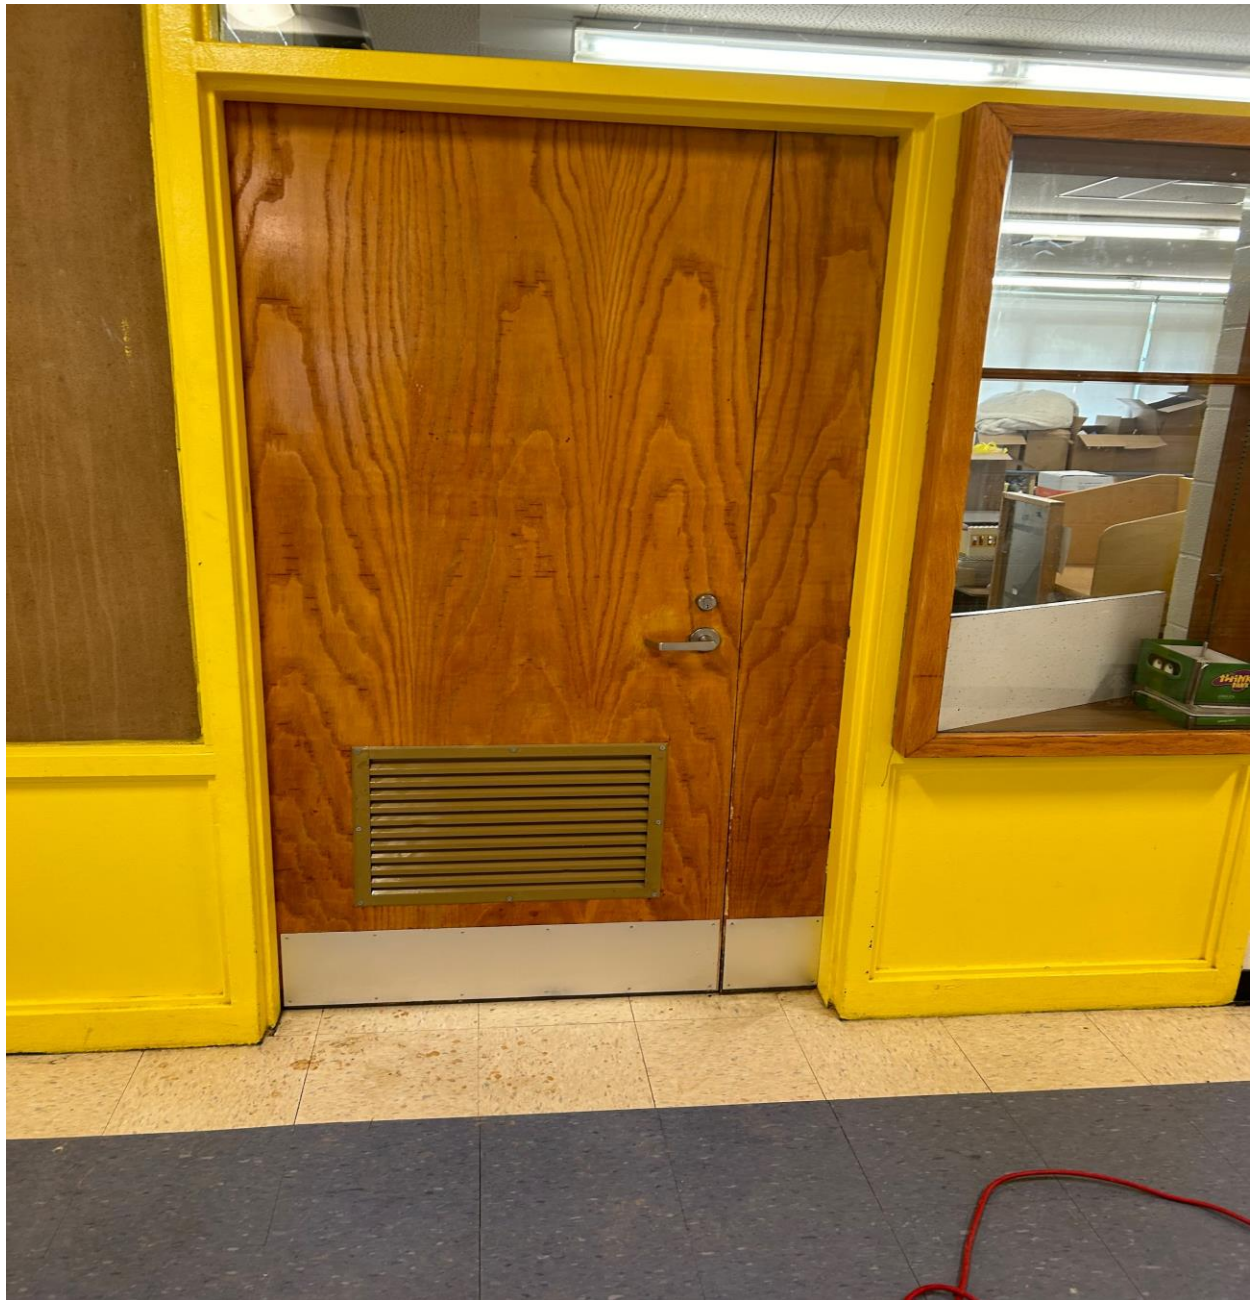
Springhurst Classrooms & Hallways

Restore classroom doors by sanding, staining doors, cleaning kick plates and louvers. Touched up paint in all of the hallways and painted several classrooms.
