Before and After

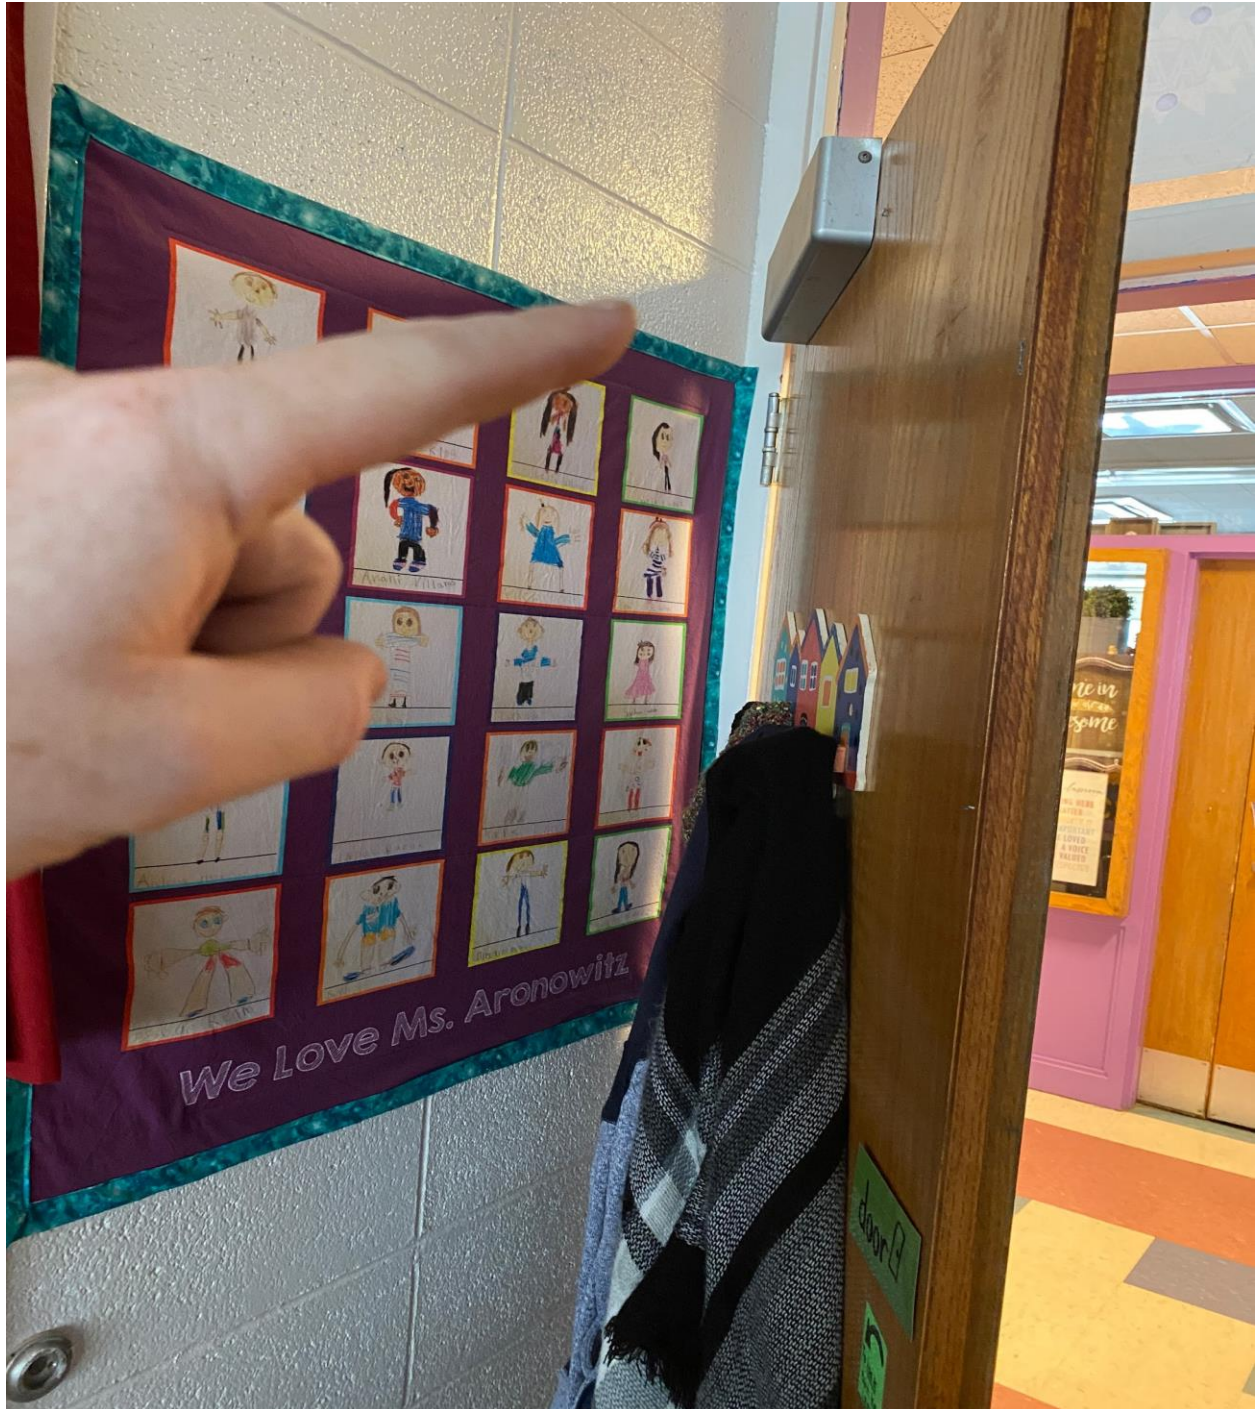
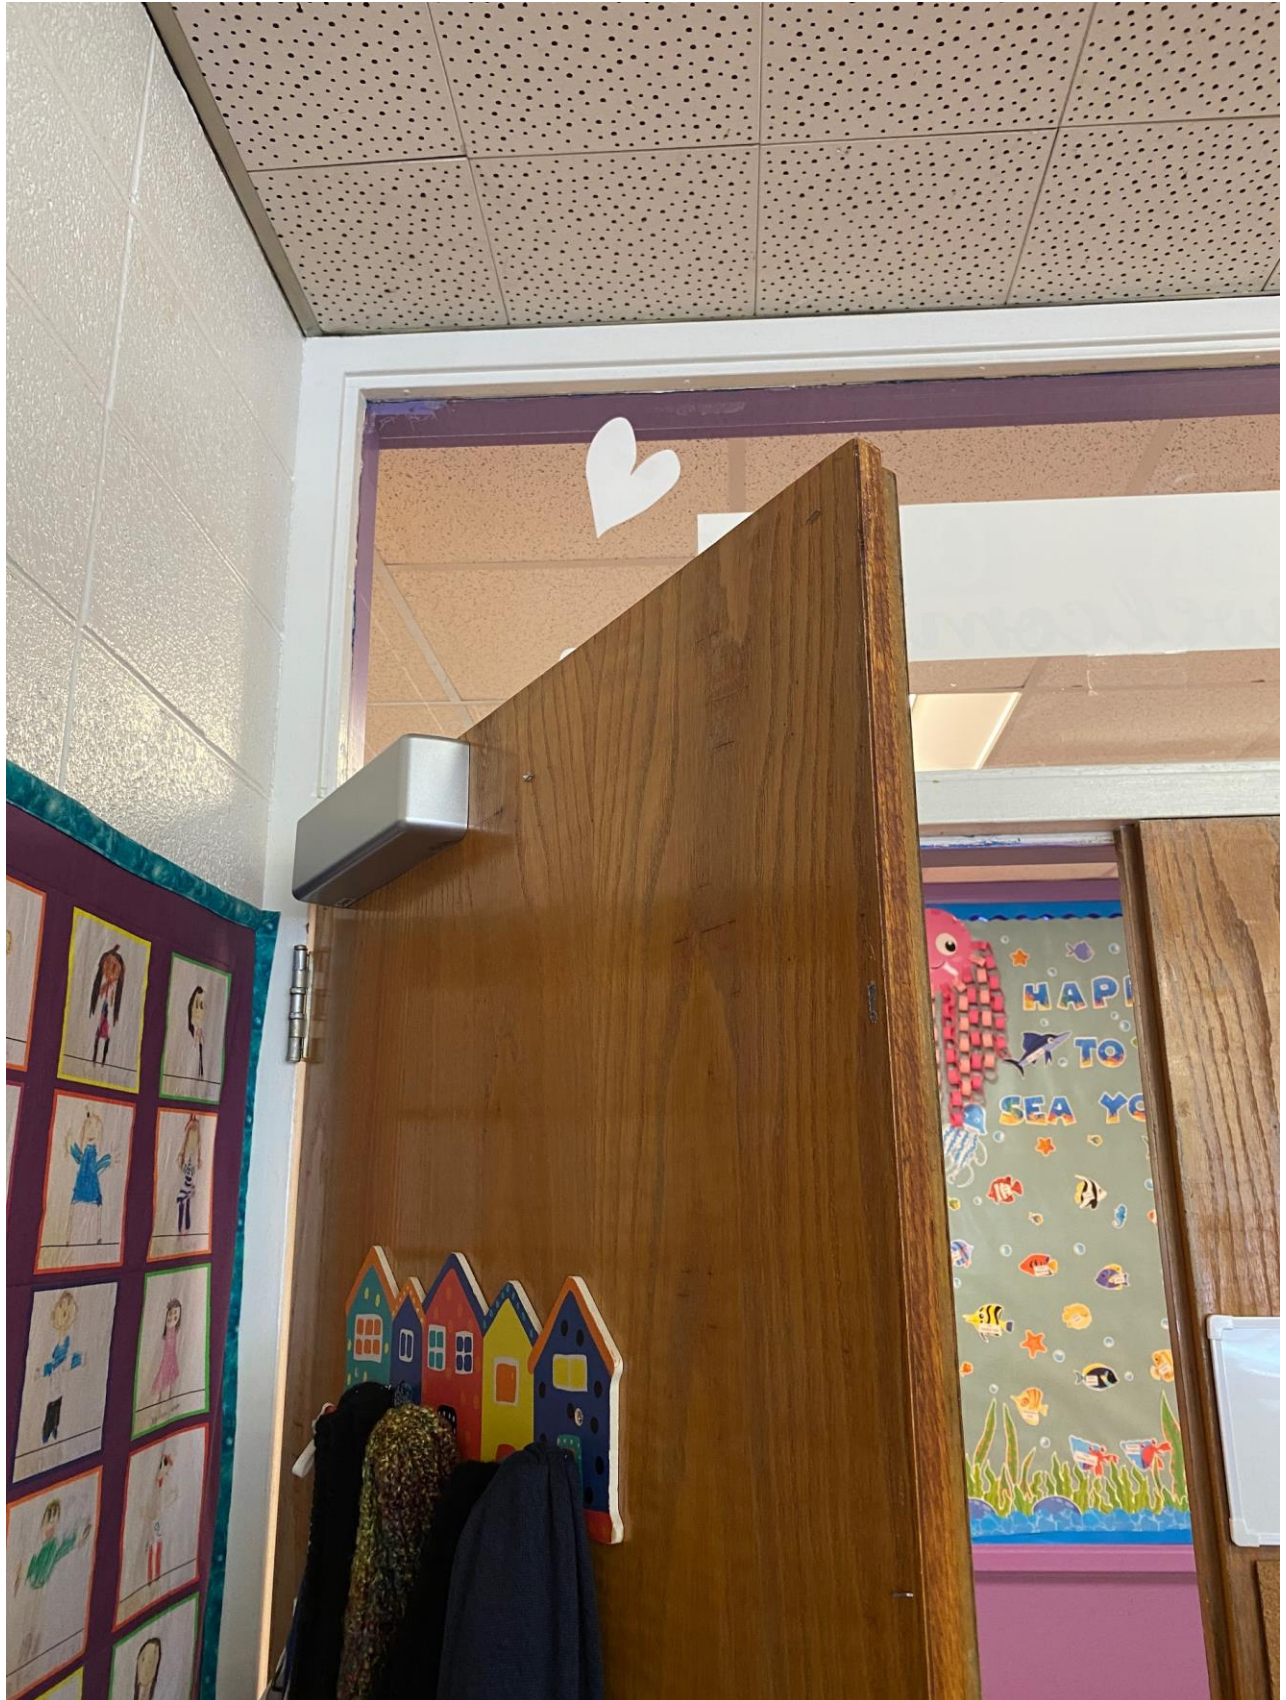
Springhurst classroom doors

Eight of 20 classroom door closers have been replaced at Springhurst Elementary. Twelve more are scheduled to be replaced during the year.

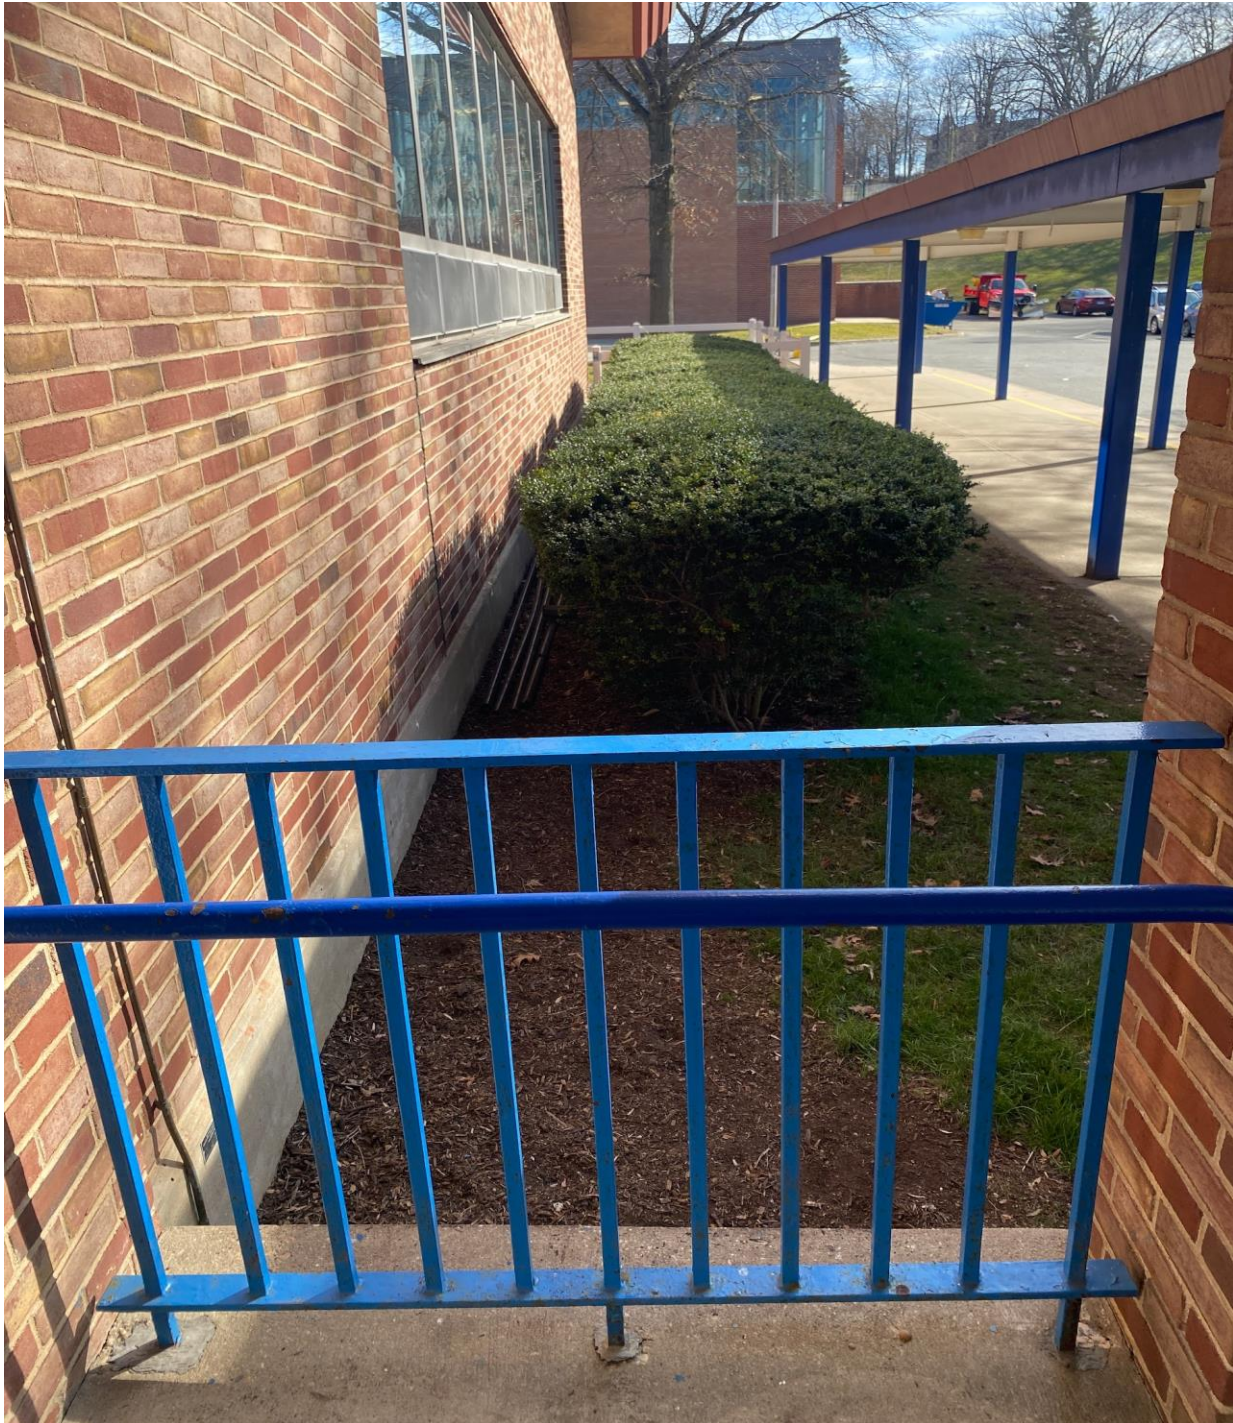
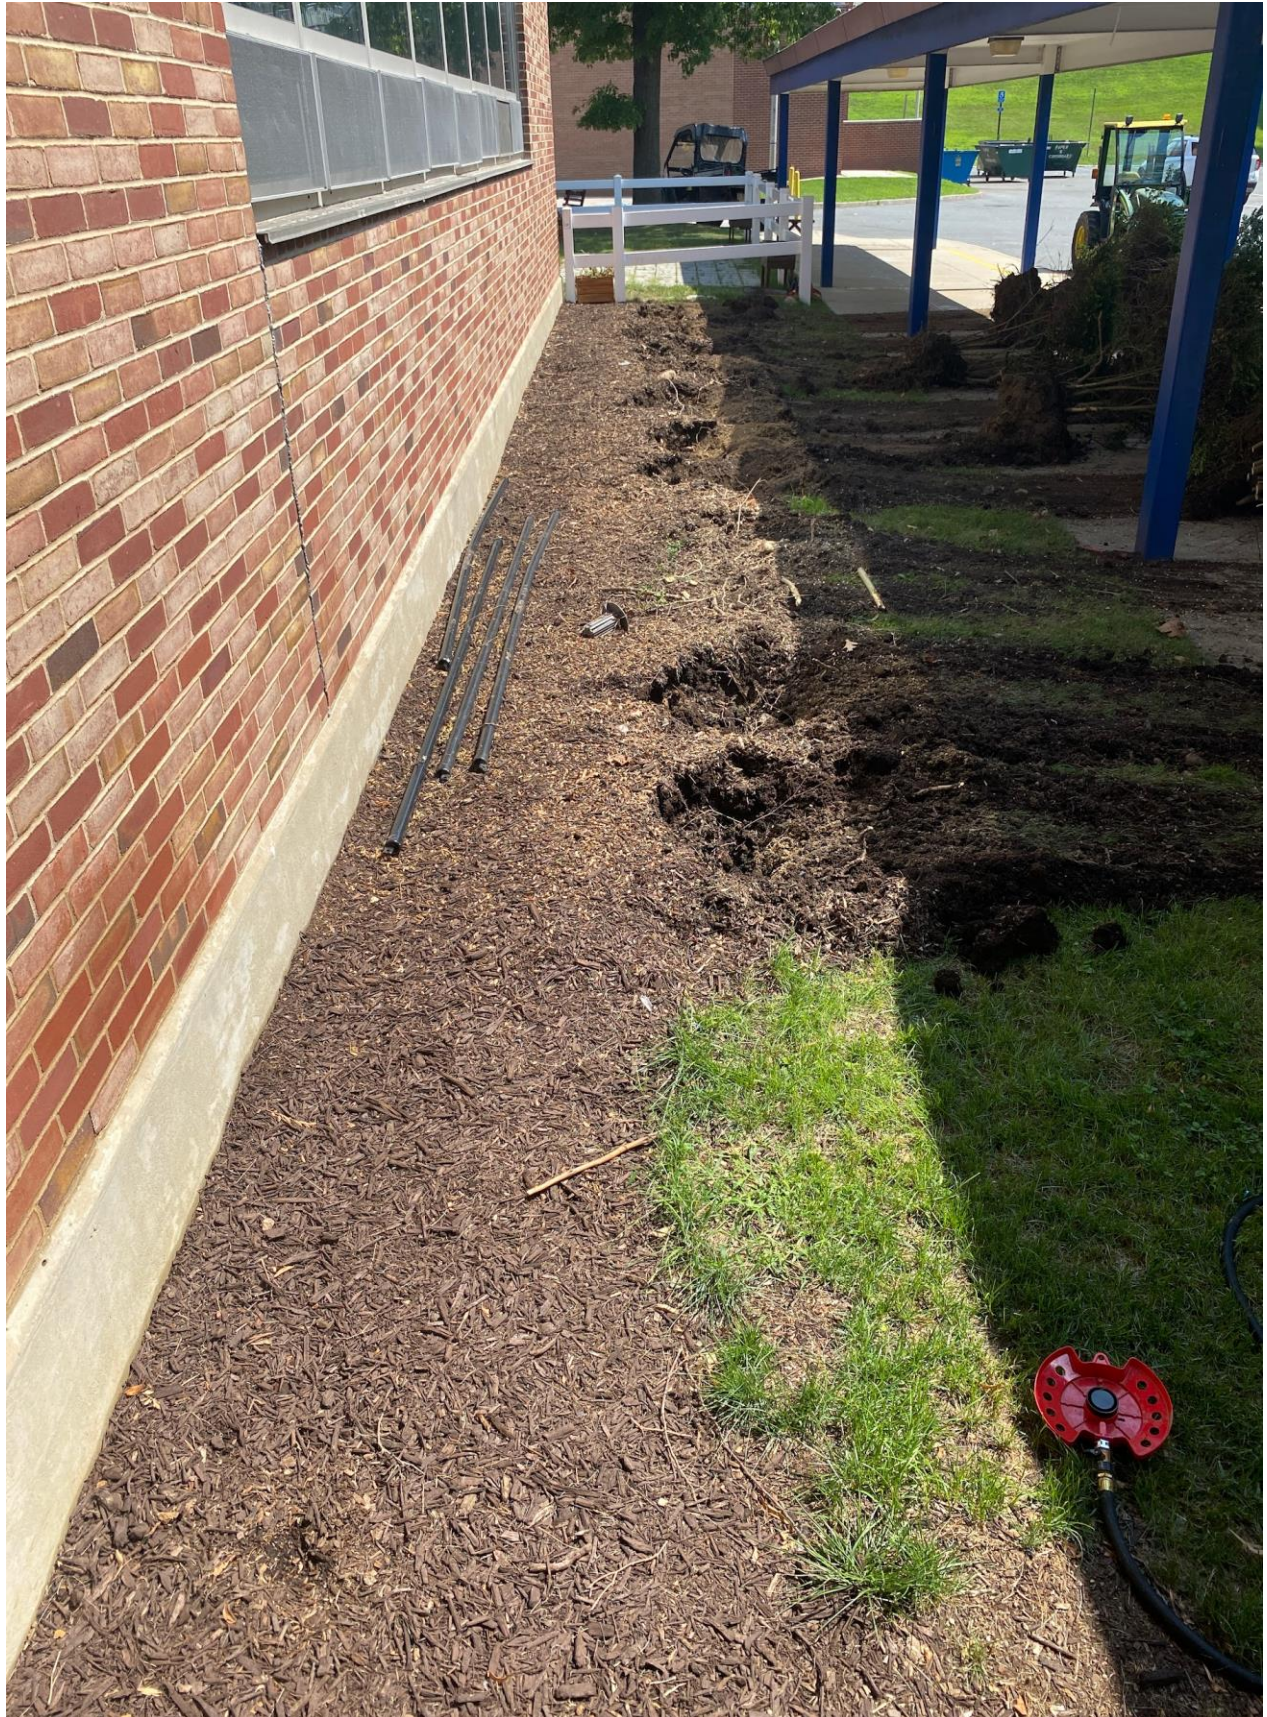
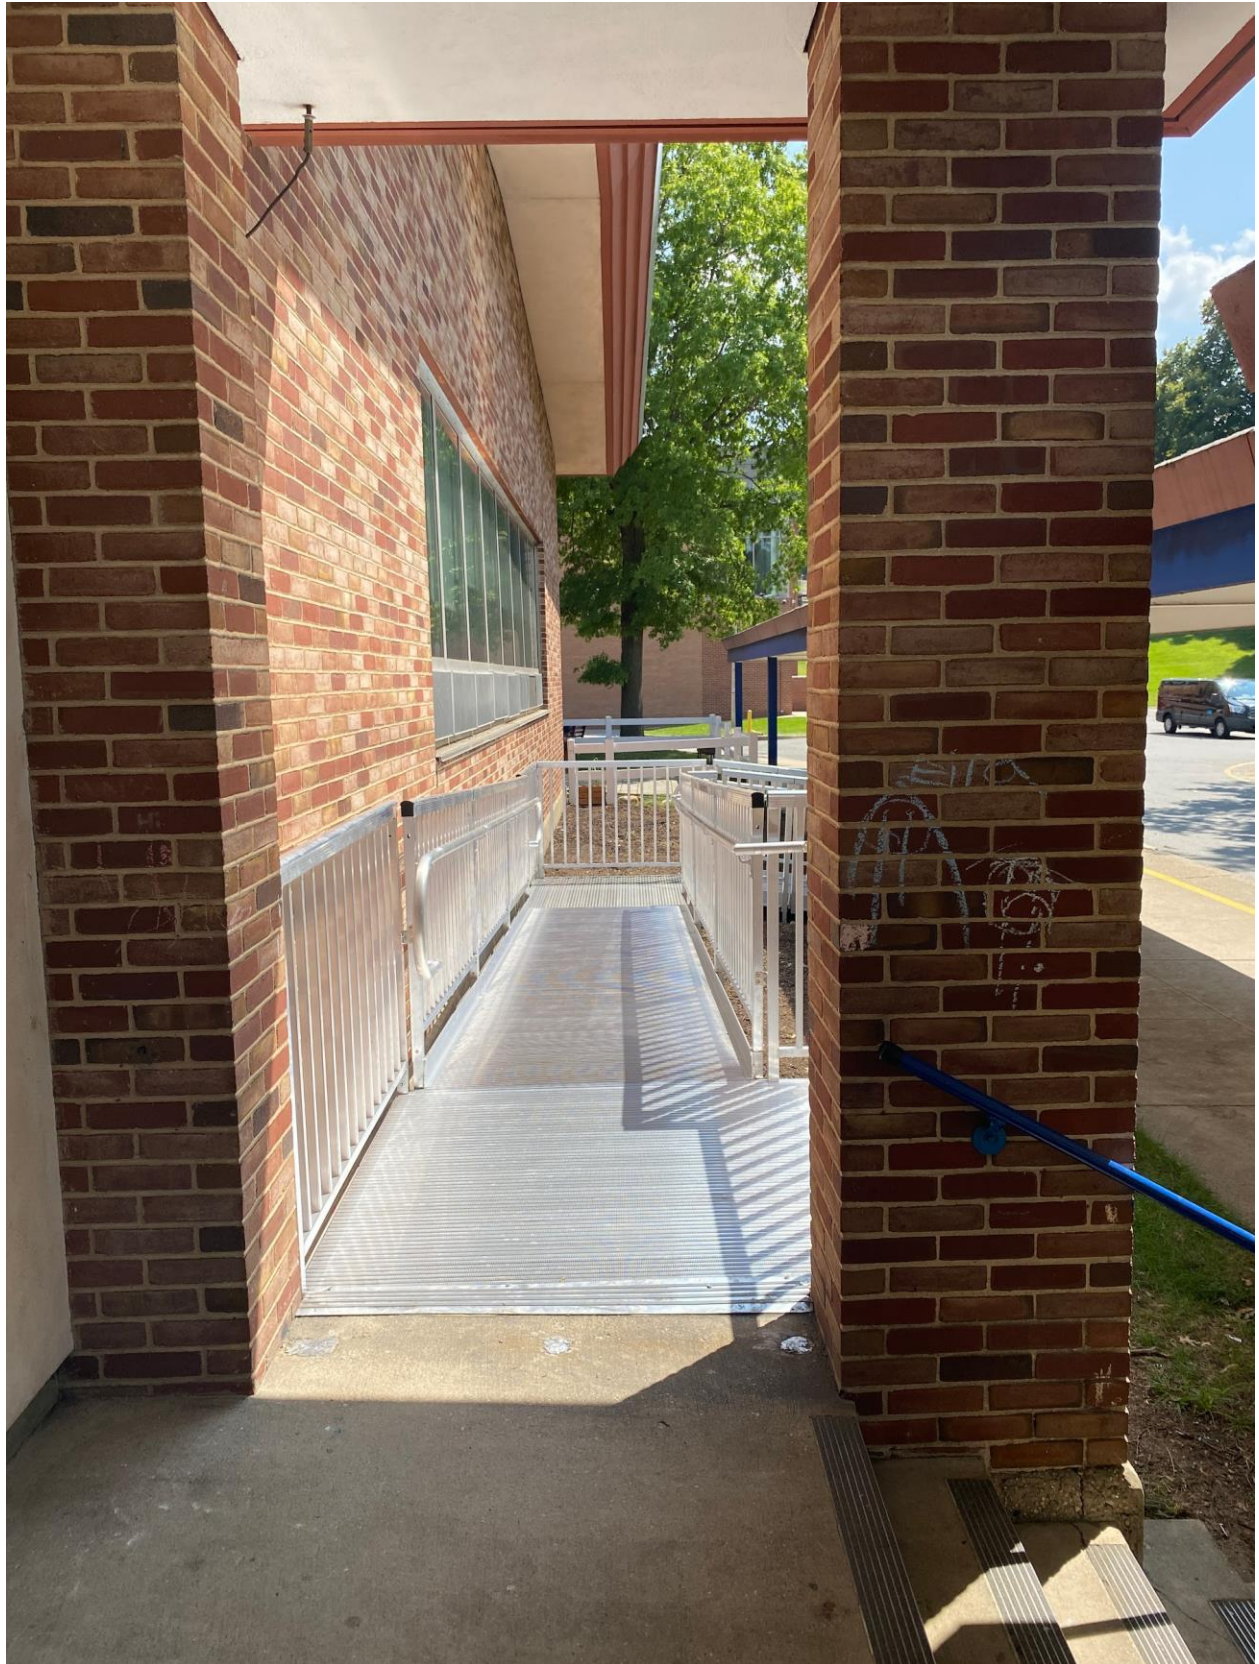
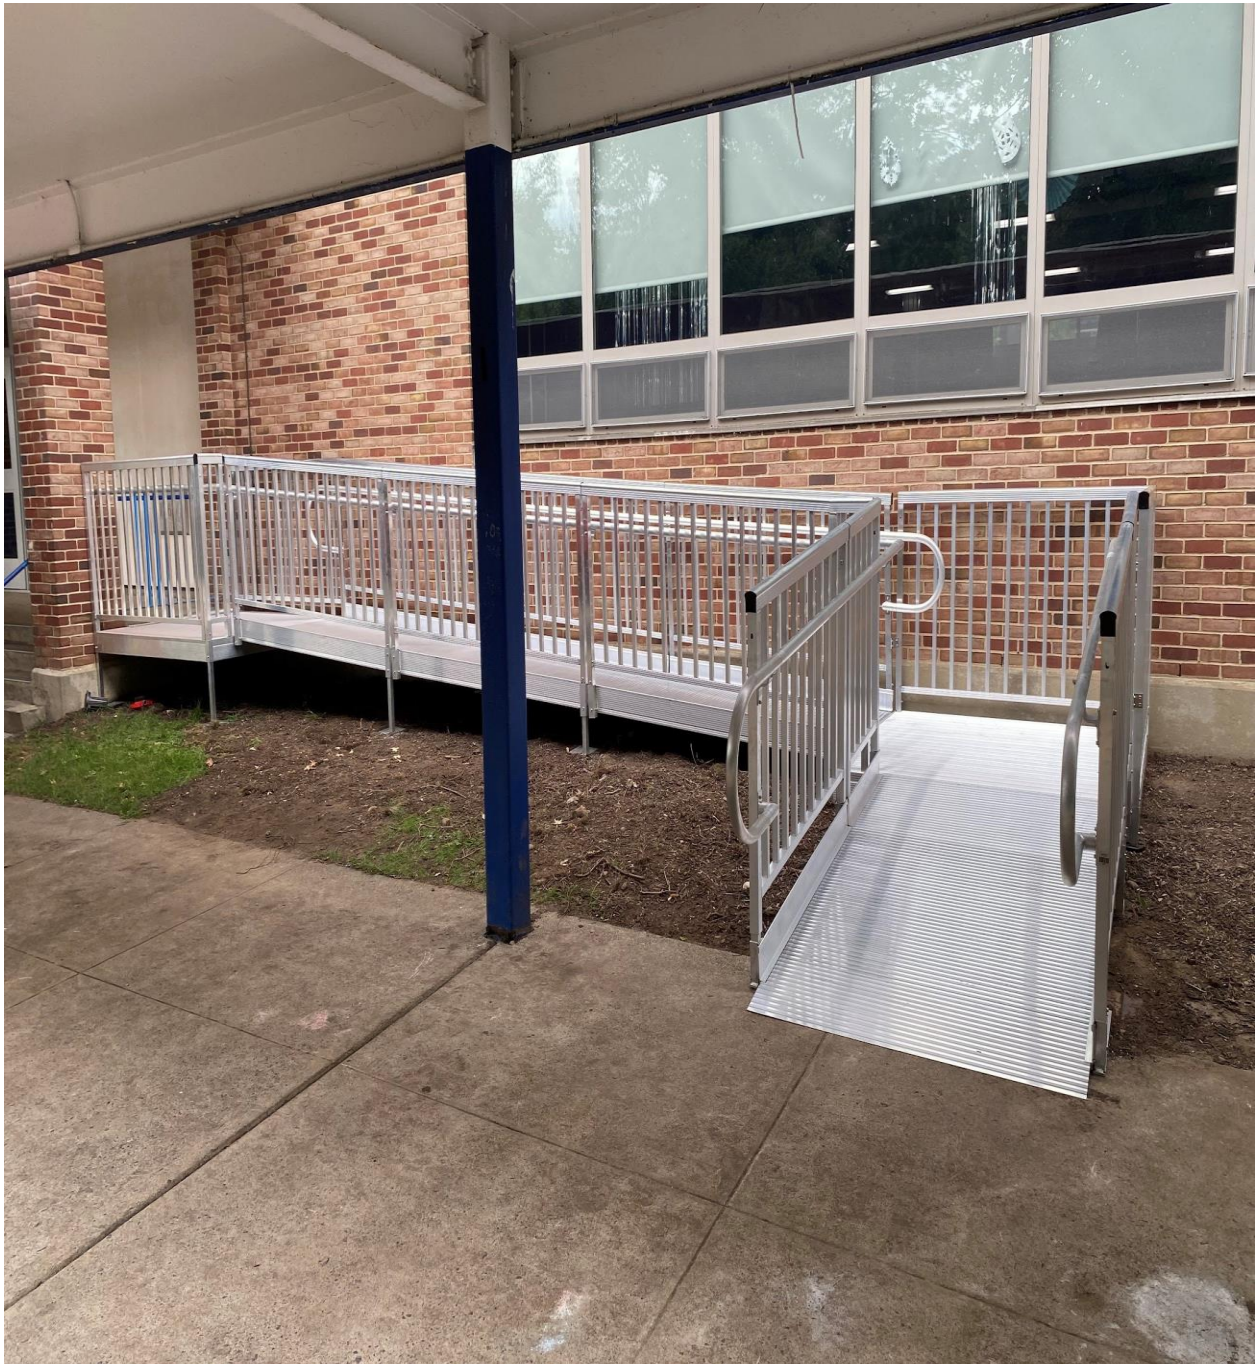
Springhurst Bus Circle

The existing railing was removed and site prepared for installation of an ADA compliant accessibility ramp.

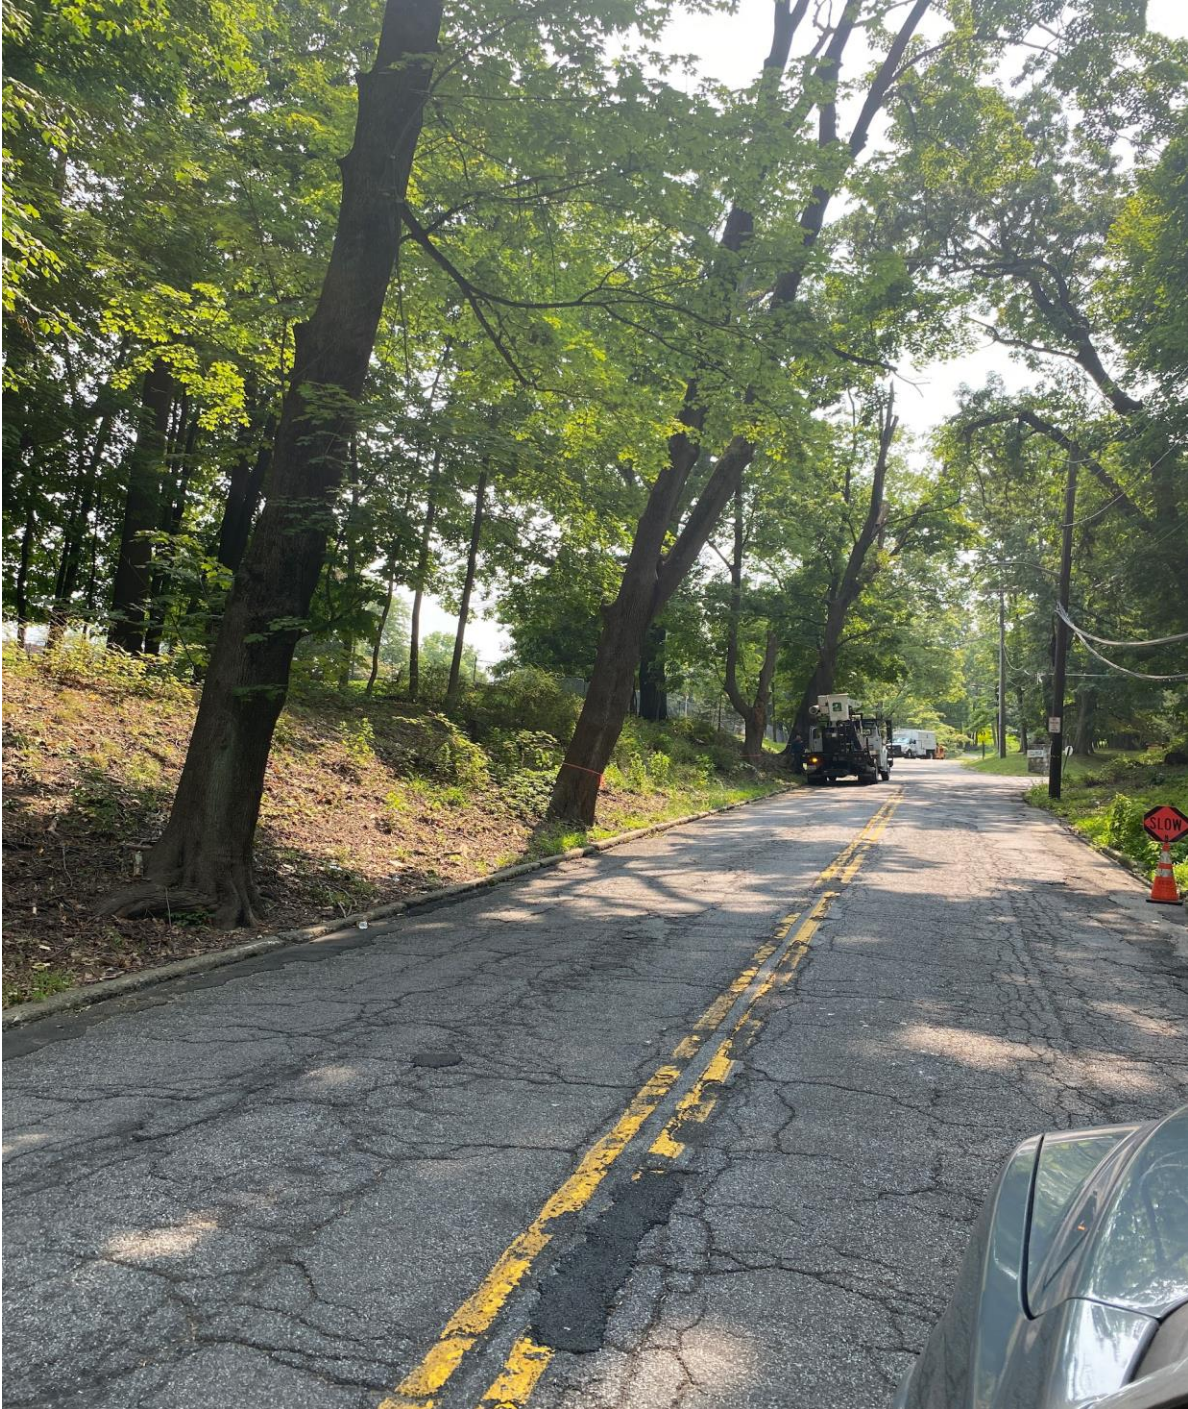
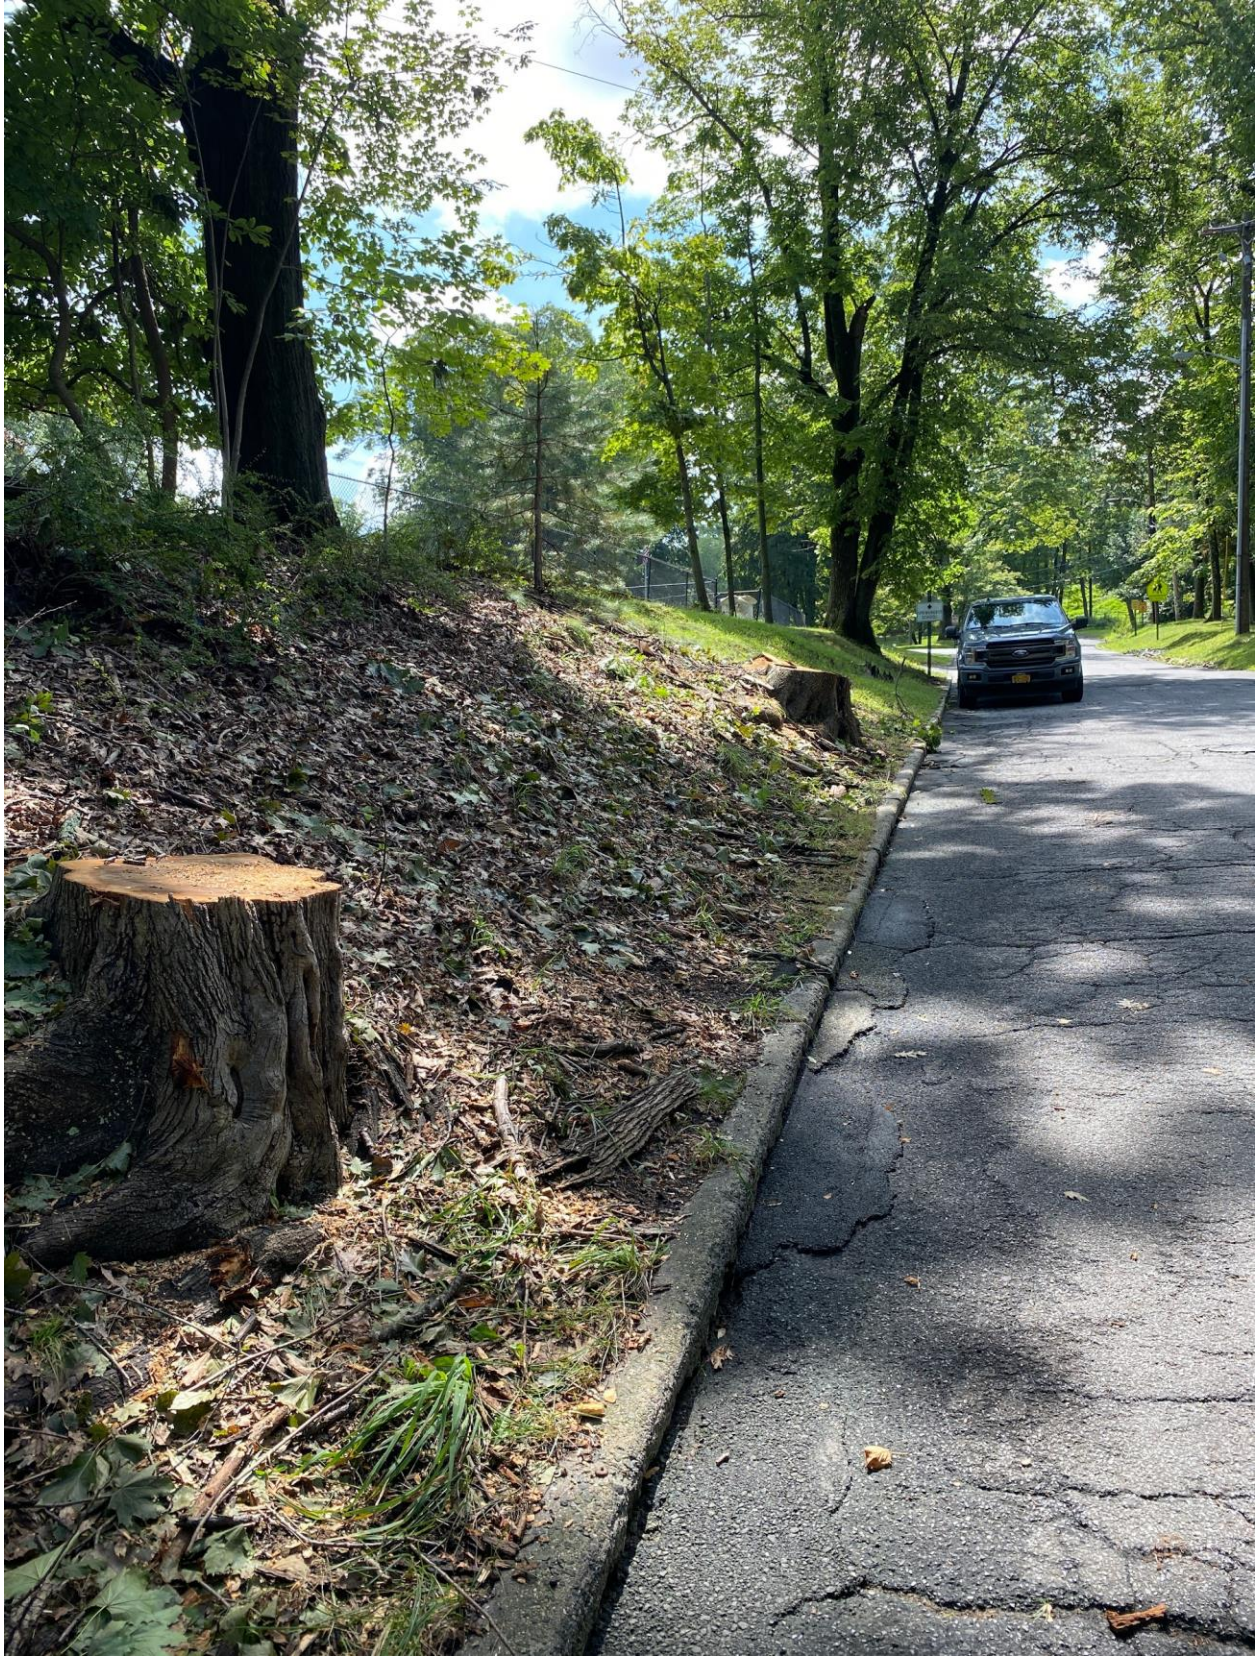
Springhurst Trees

During the 23-24 school year, Facilities hired an arborist to walk the property and create a list of trees that are recommended for removal or pruning. All the trees listed have been removed. In addition, the arborist has walked the property with the Director of Facilities and will create a new list based on his findings.

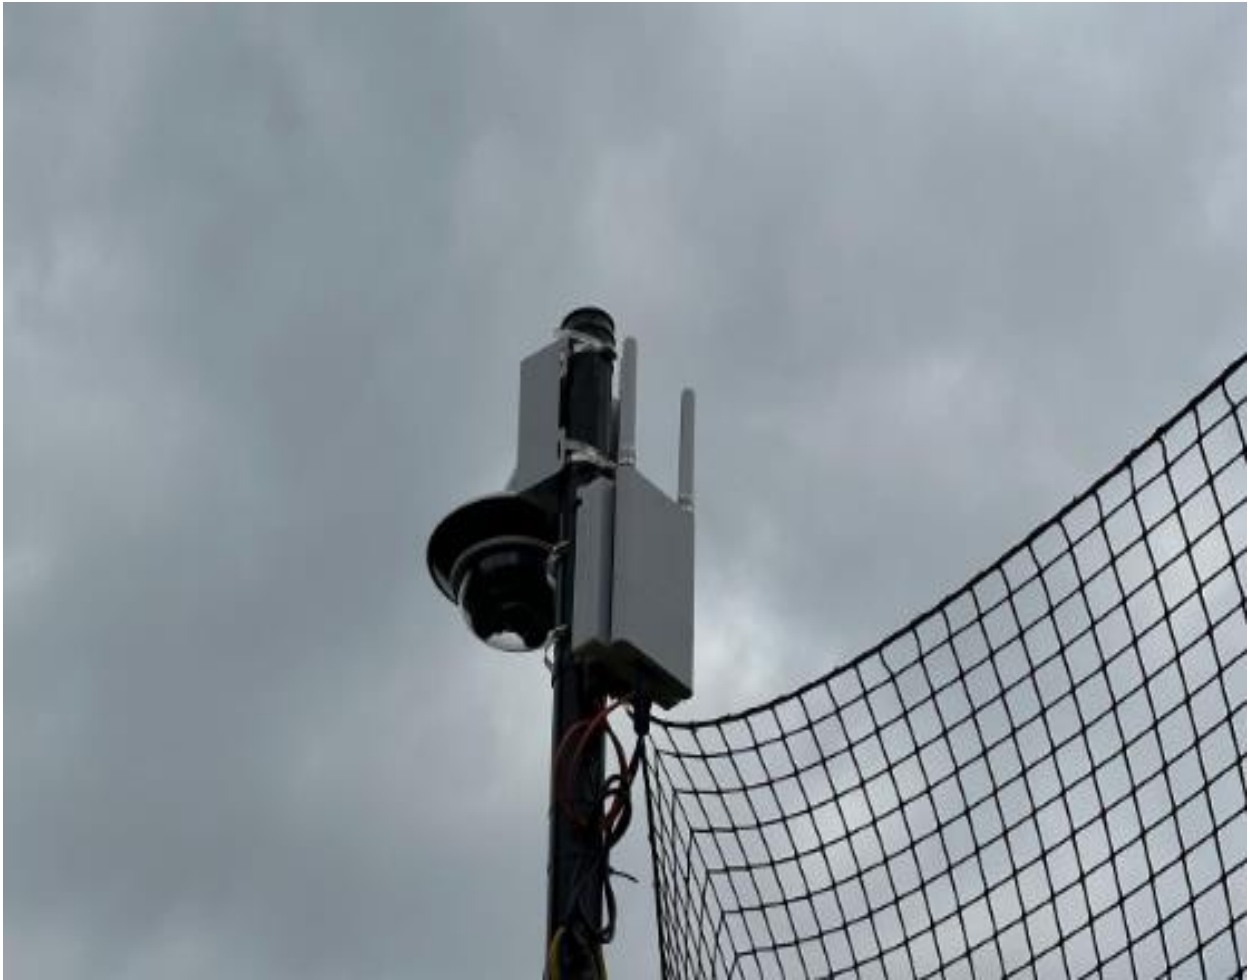
Springhurst Turf Field Camera

Installed an additional new 4-way, real-time security camera that increases security by capturing images for the turf field, softball field, tennis courts, and playground areas.

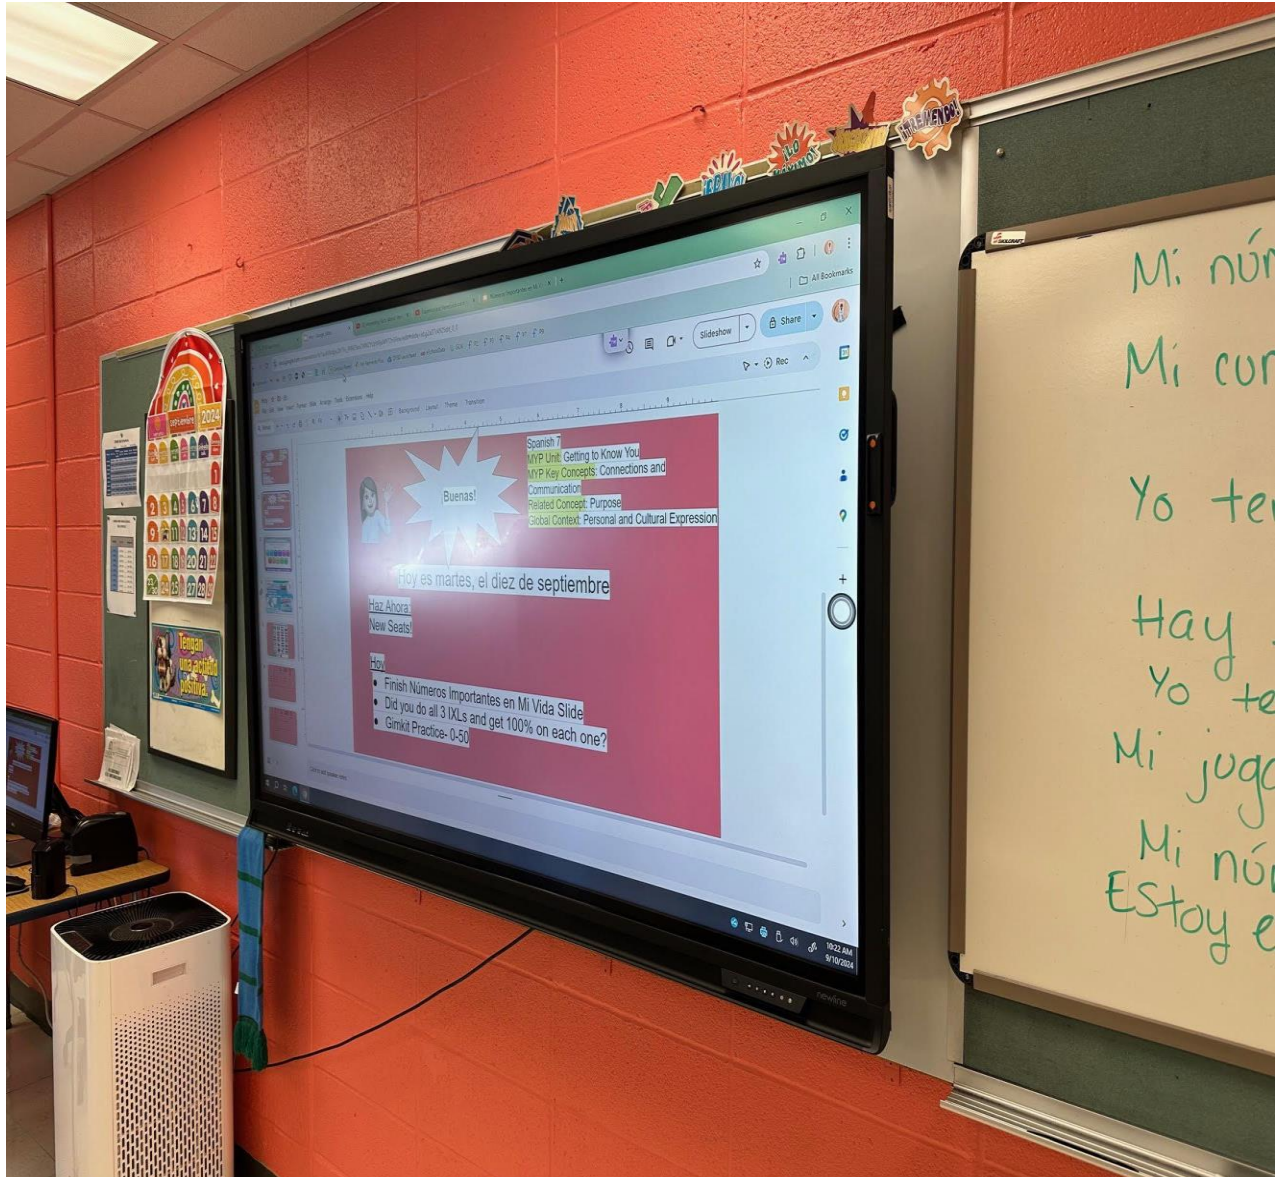
Smartboard Replacement

Replaced twenty-one Smart Boards combined throughout the district.

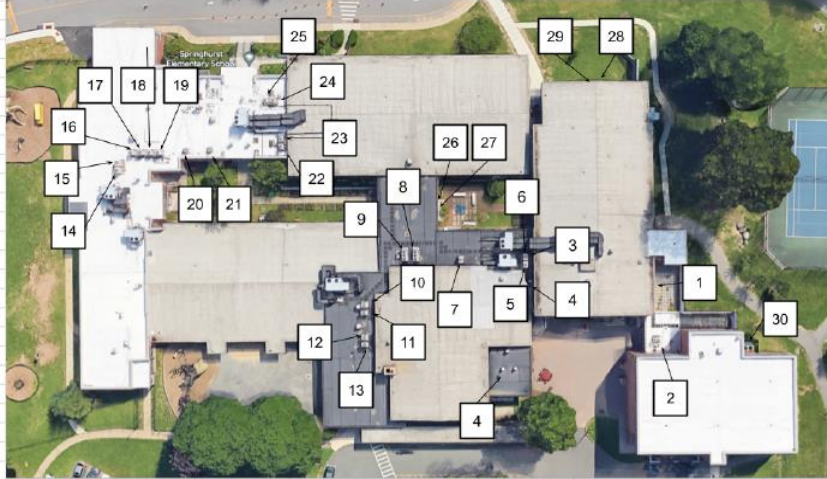
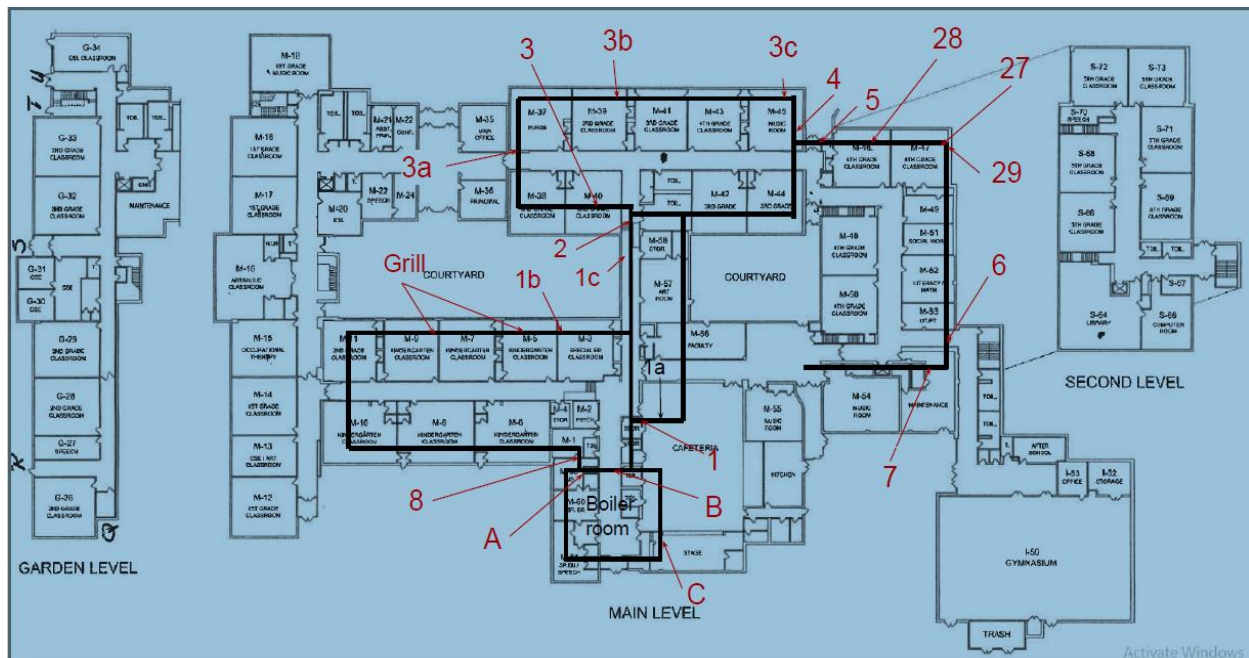
There are a number of residential condensers on the roof above the 1st and 3rd grade wing that need to be investigated and may be decommissioned
